# **Xerox® VersaLink® C7000 Color Printer & C7030 Family Color Multifunction Printer Service Manual**

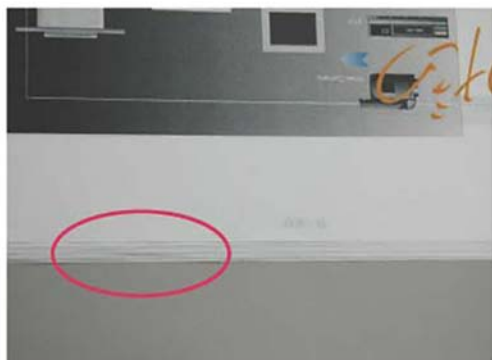
C-1-0662-A

- Lead Edge: Paper lead edge contacts the belt when it is transported from registration to Transfer.
- Trail Edge: The tail edge of paper that loops between the transfer-fusing sections, at the release of the secondary transfer nip, moves opposite to the feed direction and contacts the BTR surface, or bounds up and contacts the belt

Figure 1 Example

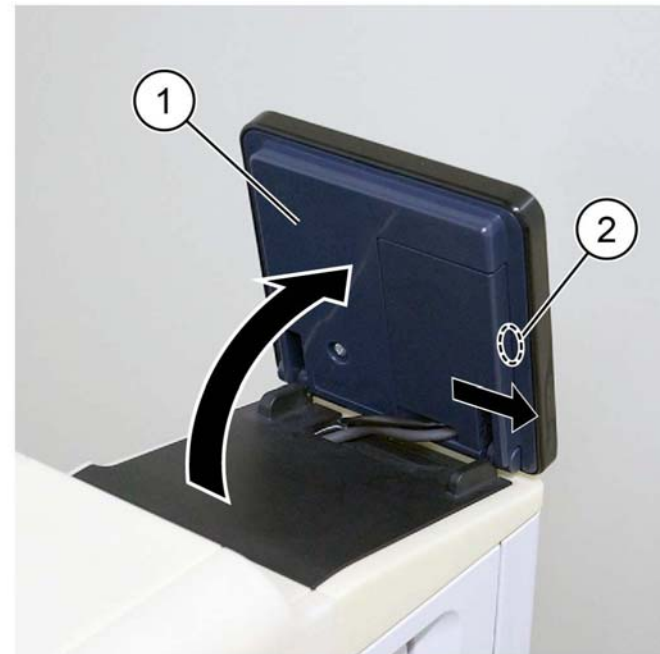
1. If possible, record the current software level by either:
  - Printing the configuration report, [GP 14](#).
  - From the user interface Home screen, touch Device, then About. Scroll down to view the Software Version.
2. Remove the UI rear cover, [Figure 1](#).
  - a. Lift the UI assembly (1) in the direction of arrow.
  - b. Insert a flat screwdriver in the gap between the UI rear cover and the UI assembly (2).

Figure 1 User interface rear cover

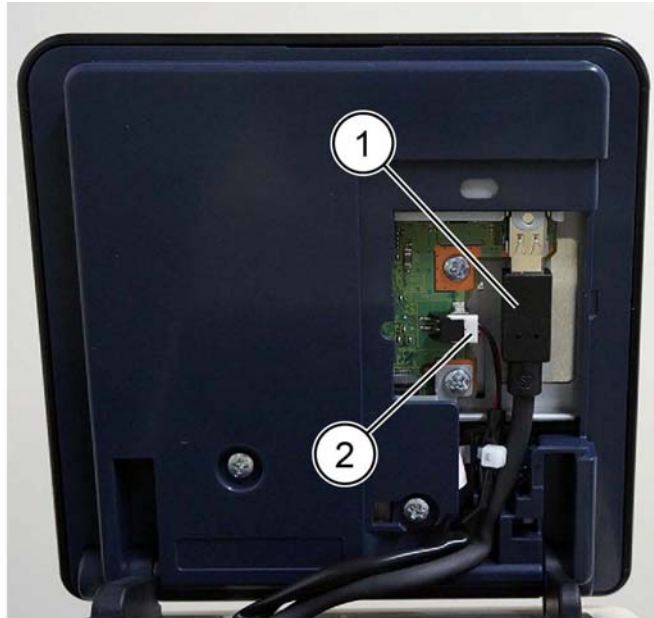
C-1-0604-A

3. Disconnect two connectors, [Figure 2](#).

Figure 2 User interface connectors

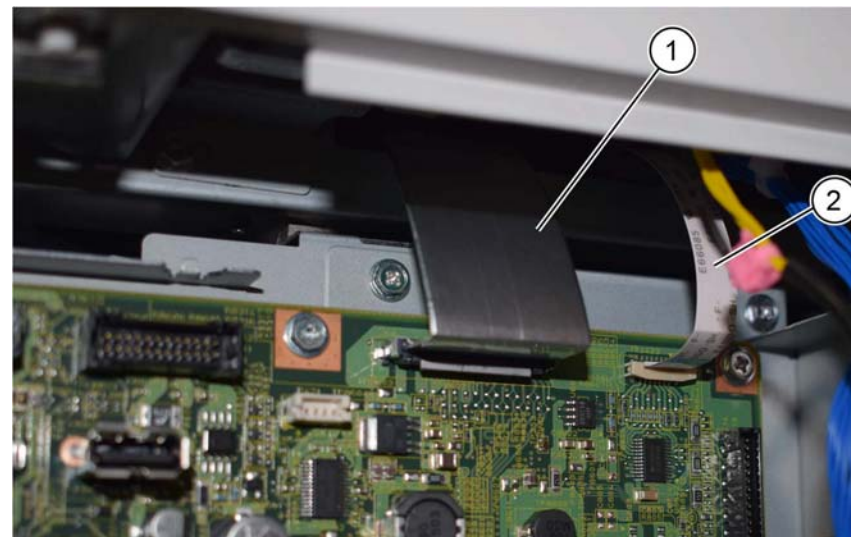
C-1-0026-A

*The FFC LED cable is secured by a clamp. Carefully lift both ends of the cable clamp simultaneously to release the cable.*

11. **(C7030F only)**. Carefully disconnect the CCD ribbon cable (1) and the FFC LED cable (2), **Figure 10**.

**Figure 10 Cables**

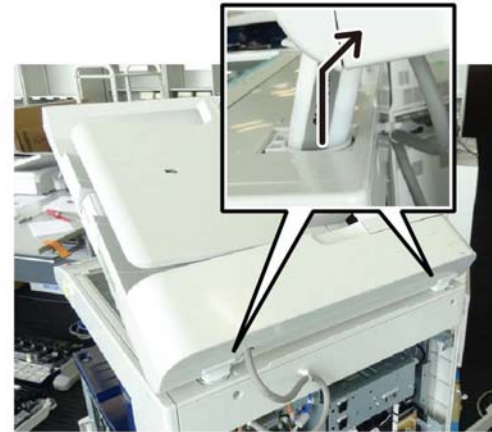
Figure 2 DADF removal

4. Remove the DADF, [Figure 2](#).

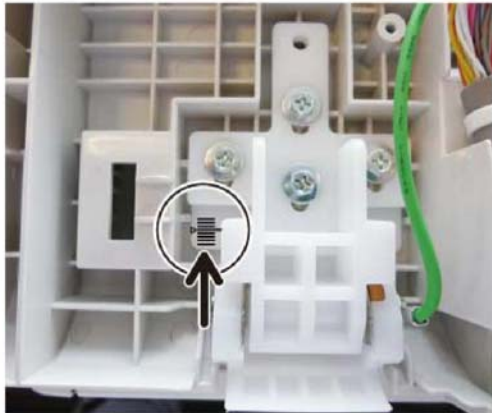
Figure 1 Position

1. Remove the DADF rear cover, [REP 5.4](#).
2. Remove the DADF, [REP 5.1](#).
3. Record the position of right counter balance, [Figure 1](#).

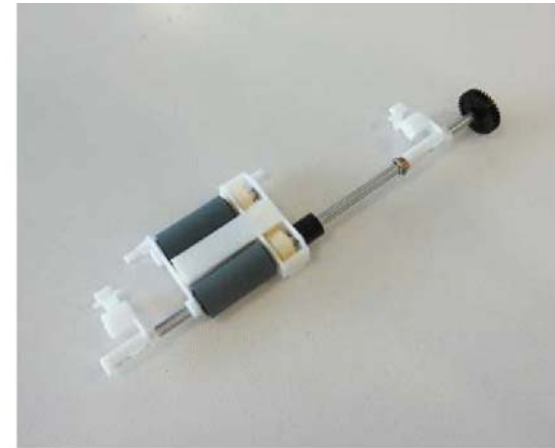
Figure 2 Removed feed/nudger roll assembly

**NOTE:** The removed feed/nudger roll assembly is shown in [Figure 2](#).

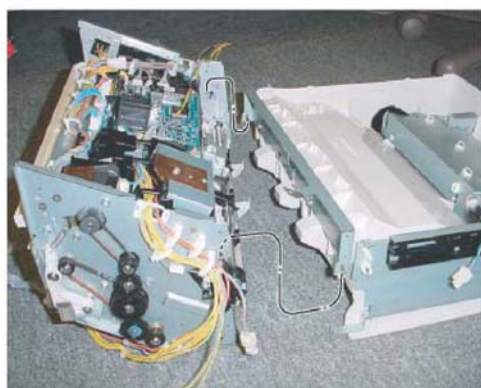
1. The replacement is the reverse of the removal procedure.
2. Install the stacker tray assembly and integrated office finisher as shown in [Figure 5](#).

Figure 5 Stacker tray assembly installation

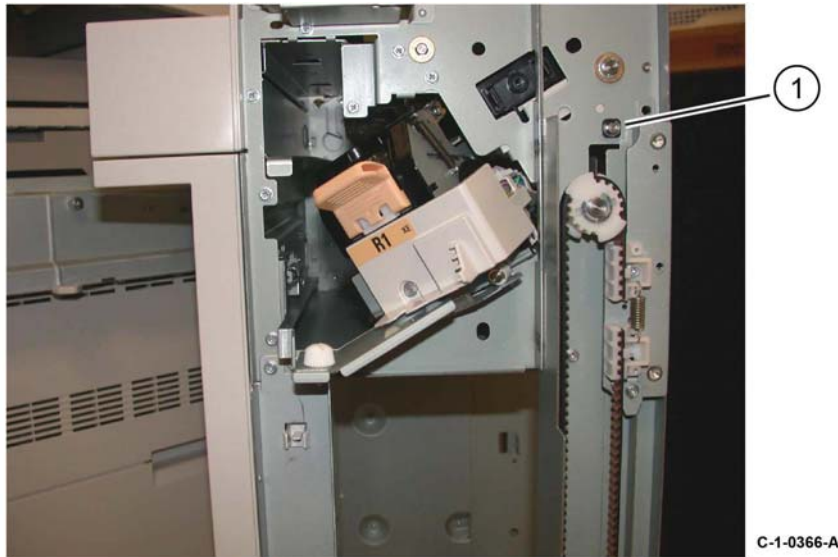
13. Remove the front E-ring and the bushing (1) from the set clamp shaft assembly, [Figure 5](#).

**Figure 5 Front E-ring removal**

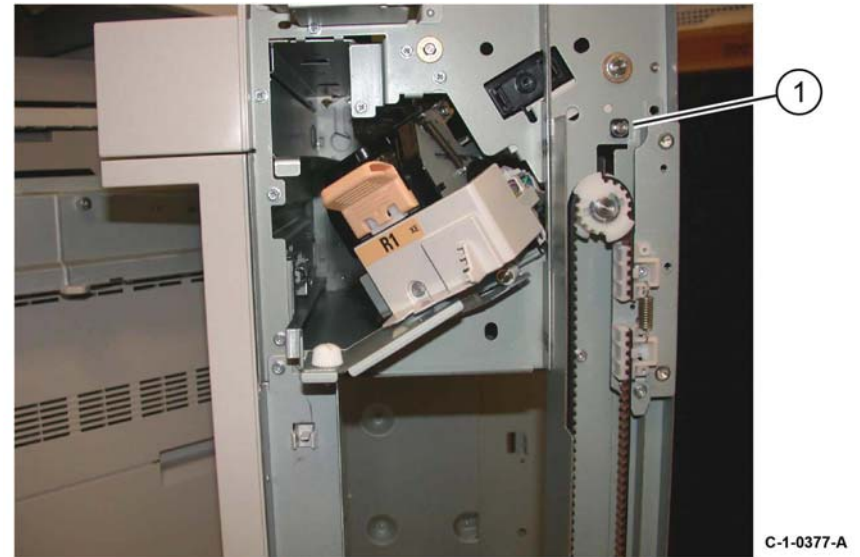
9. Install the bushing onto the front end of the set clamp shaft, then install the E-ring (1), [Figure 16](#).

Figure 16 Bushing and E-ring

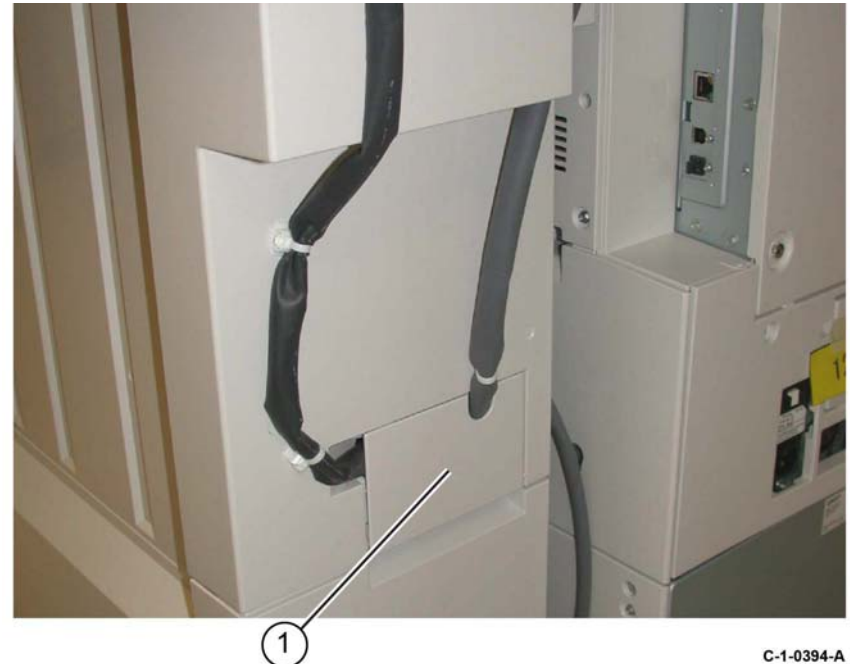
2. Remove the connector cover (1), [Figure 2](#).

Figure 2 Connector cover

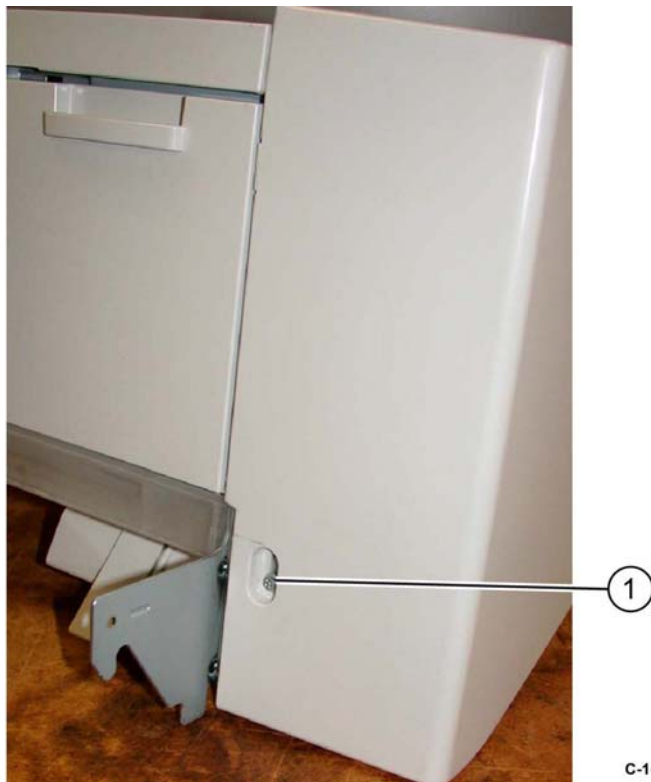
1. Remove the booklet maker assembly from the finisher, [REP 13.31](#).
2. Remove the screw (1), [Figure 1](#).

Figure 1 Screw removal

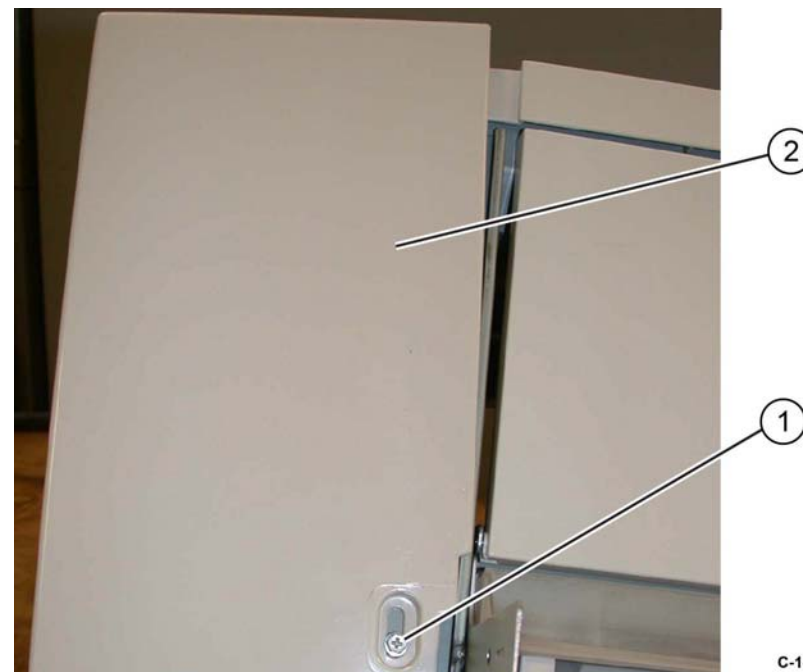
C-1-0400-A

4. Remove the screw (1), then the booklet rear cover (2), [Figure 2](#).

Figure 2 Booklet rear cover removal

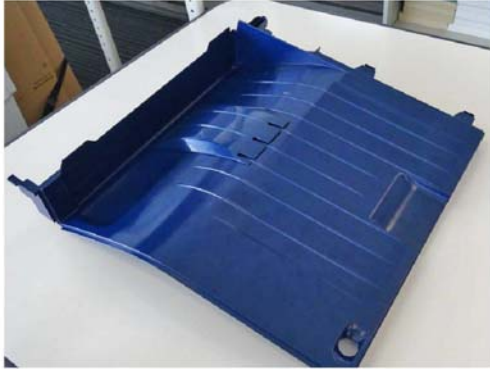
**NOTE:** The removed top cover is shown in [Figure 2](#).

Figure 2 Removed top cover

1. The replacement is the reverse of the removal procedure.
2. When installing the top cover, align the bosses on the rear of the top cover with the mounting holes.

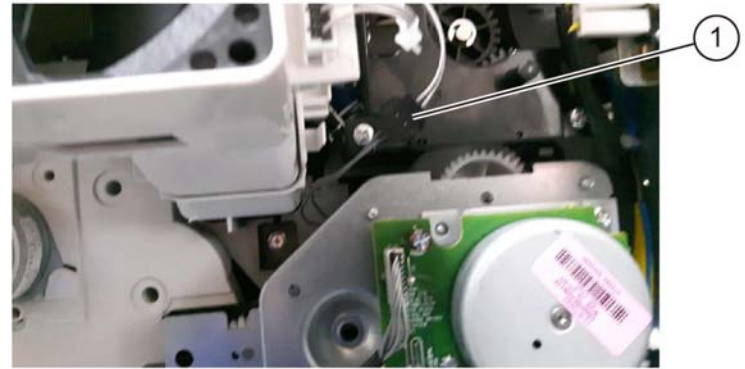
C-1-0632-A

10. Disconnect the drive assembly connector (1), Figure 2.

Figure 2 Drive assembly connector

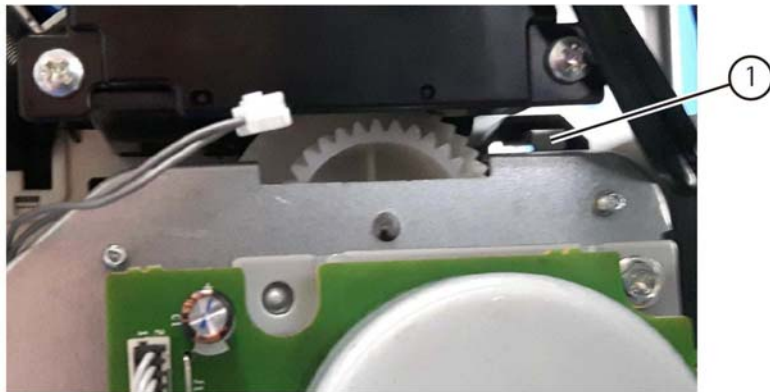
C-1-0635-A

13. Release the hook (1), carefully move the drive assembly down and remove the drive assembly, [Figure 5](#).

**Figure 5 Drive assembly removal**

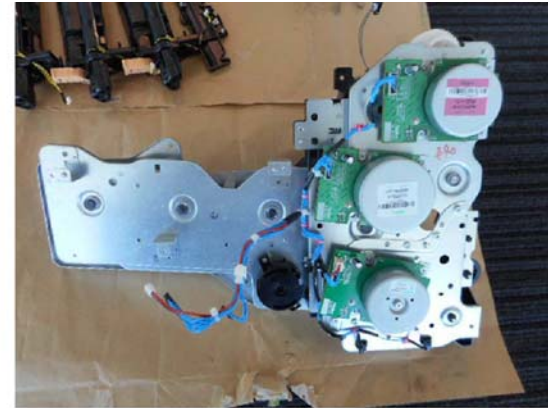
C-1-0636-A

This shows the removed drive assembly, [Figure 6](#).

**Figure 6 Removed drive assembly**

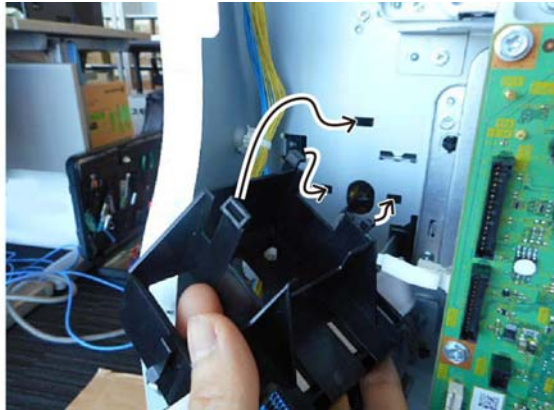
C-1-0638-A

- When installing the FCC cable guide, FCC cables and wire harness, insert the three hooks of the FCC Cable Guide into the installation holes on the metal chassis, [Figure 8](#).

Figure 8 FCC guide insertion

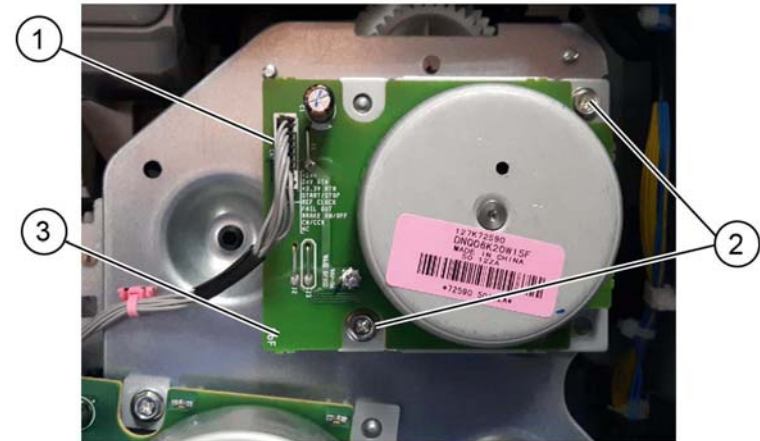
C-1-0642-A

- Remove the upper rear cover, [REP 28.5](#).
- Remove the lower rear cover, [REP 28.6](#).
- Remove the LVPS assembly, [REP 1.4](#).
- Remove the fusing unit drive motor PWB, [Figure 1](#).
  - Remove the connector (1).
  - Remove two screws (2).
  - Remove the fusing unit drive motor PWB (3).

Figure 1 Fusing unit drive removal

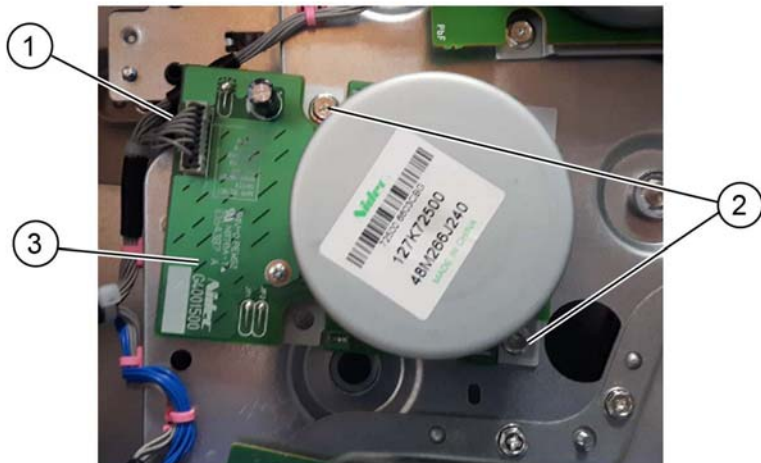
C-1-0643-A

1. Remove the upper rear cover, [REP 28.5](#).
2. Remove the lower rear cover, [REP 28.6](#).
3. Remove the LVPS assembly, [REP 1.4](#).
4. Remove the main motor PWB, [Figure 1](#).
  - a. Remove the connector (1).
  - b. Remove two screws (2).
  - c. Remove the main motor PWB (3).

Figure 1 Main motor PWB removal

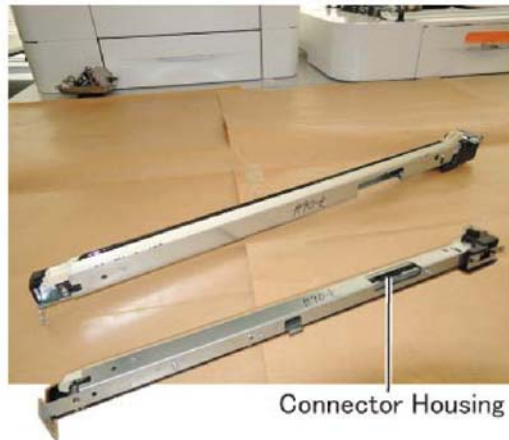
Figure 6 Removed LPH

13. Remove the LPH (K), [Figure 6](#).

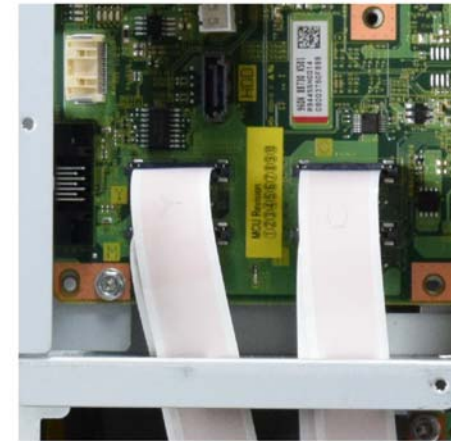
**Figure 4 FFC cables**

5. Disconnect the four FFC cables, [Figure 4](#):
  - a. Carefully disconnect the FFC cables (1) by releasing the side clips.
  - b. Pull down the FFC cables through the ESS chassis.

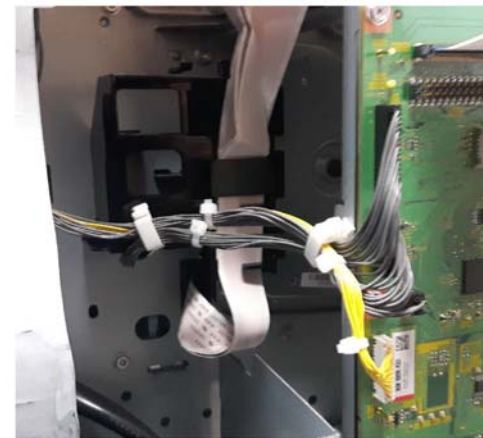
**Figure 5 Wire harness removal**

6. Disconnect cables (1) from drive PWB, remove the harness clips (2), and remove the harness from FFC guide, [Figure 5](#).

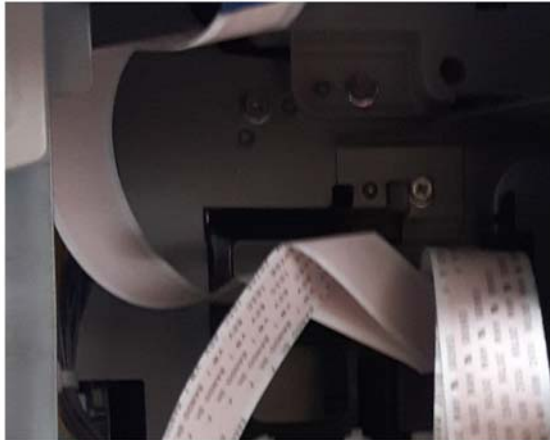
**Figure 6 FFC guide removal**

7. Disengage the hook (1), and remove the FFC guide (2), [Figure 6](#).

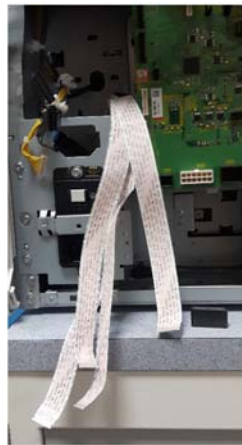
**Figure 7 FFC cables removed at rear of unit**

8. Remove the ferrite core and FFC cables from the FFC guide.
9. Carefully pull each FFC cable through the ferrite core.  
Reference: This shows the rear of the unit with FCC cables removed from ferrite core, [Figure 7](#).

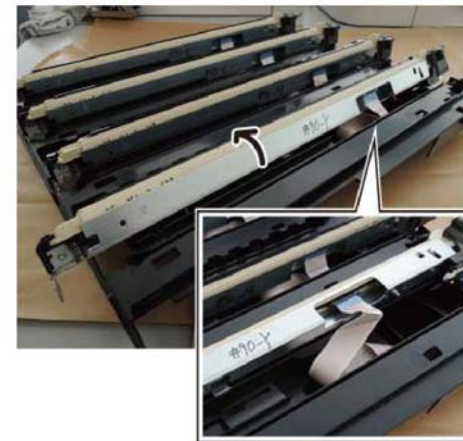
23. Push the LPH (Y) towards the direction of the arrow, and place it so the right side of LPH (Y) is on the top, [Figure 13](#).

**Figure 13 Alignment**

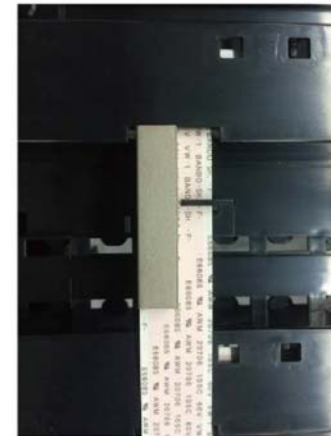
1. The replacement is the reverse of the removal procedure.
2. When replacing the K FFC cable, insert the cable in the correct position of the gasket within the marking guide, [Figure 16](#).

Figure 16 FFC cable

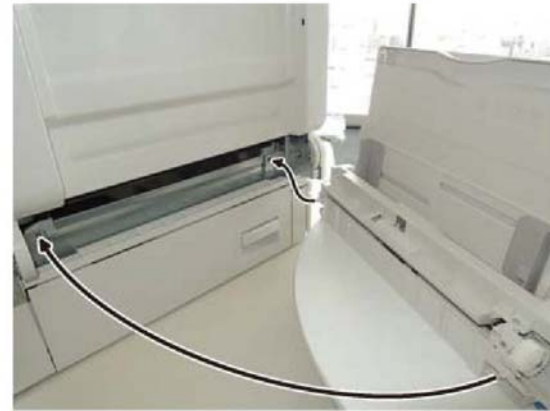
1. The replacement is the reverse of the removal procedure.
2. When installing the bypass tray, insert the two bypass tray bosses into the holes in the frame, **Figure 4.**

**Figure 4 Replacement**

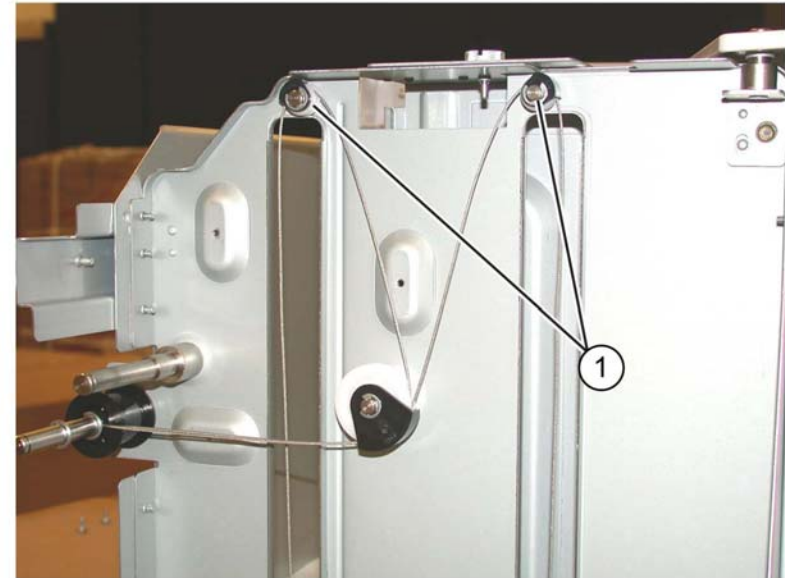
4. Prepare to remove the tray rear cables. Remove two E-rings, wire guides and pulleys (1), [Figure 3](#).

Figure 3 Preparation

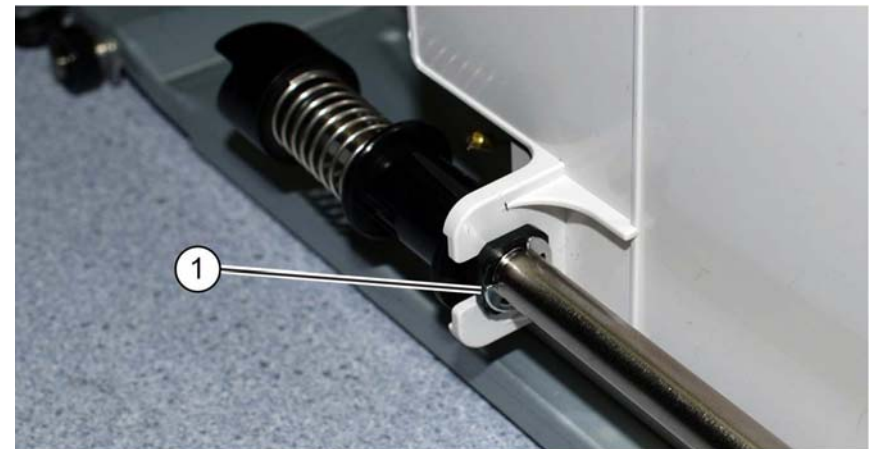
6. Remove the E-clip (1), **Figure 3**:

Figure 3 Rear E-clip

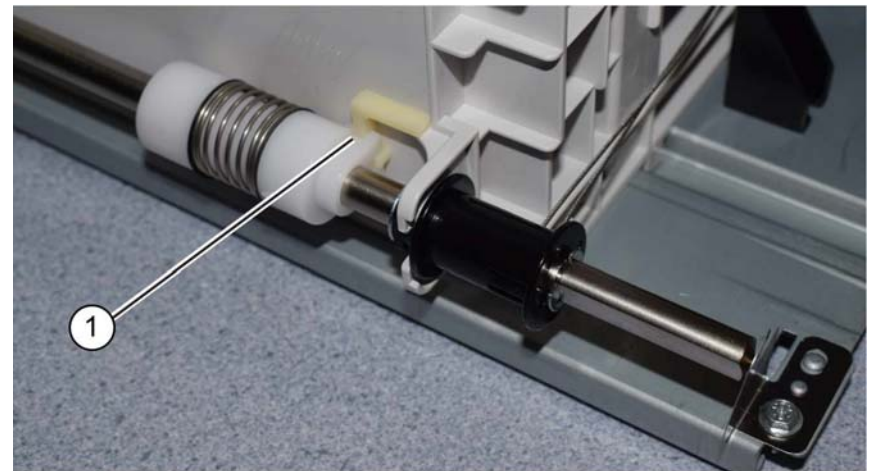
3. Ensure the brake (1) is correctly positioned against the tray frame, Figure 6.

Figure 6 Brake

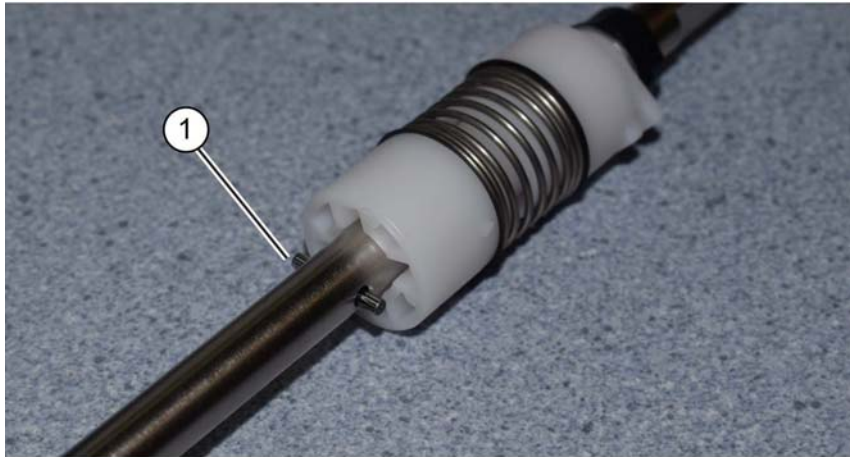
2. Ensure the brake securing pin (1) is installed correctly, [Figure 5](#).

Figure 5 Pin

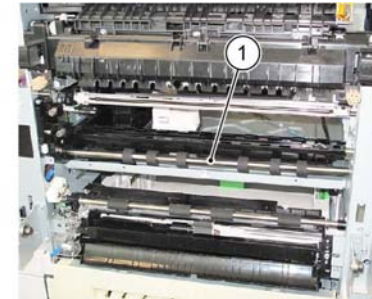
11. Remove the registration roll, **Figure 4**.

**Figure 4 Registration roll removal**

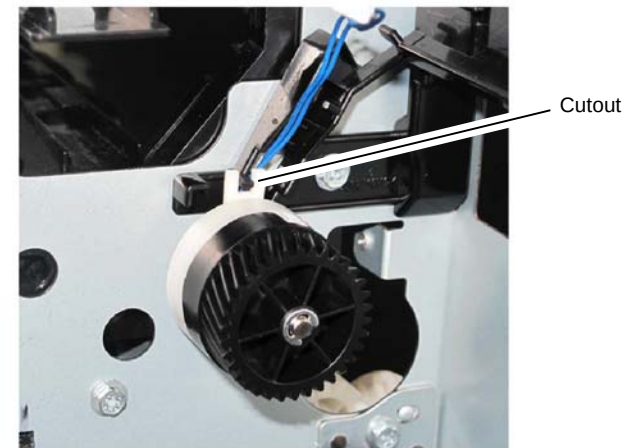
1. The replacement is the reverse of the removal procedure.
2. When installing the registration clutch assembly, align the cutout with the harness guide tab, **Figure 5**.

**Figure 5 Alignment**

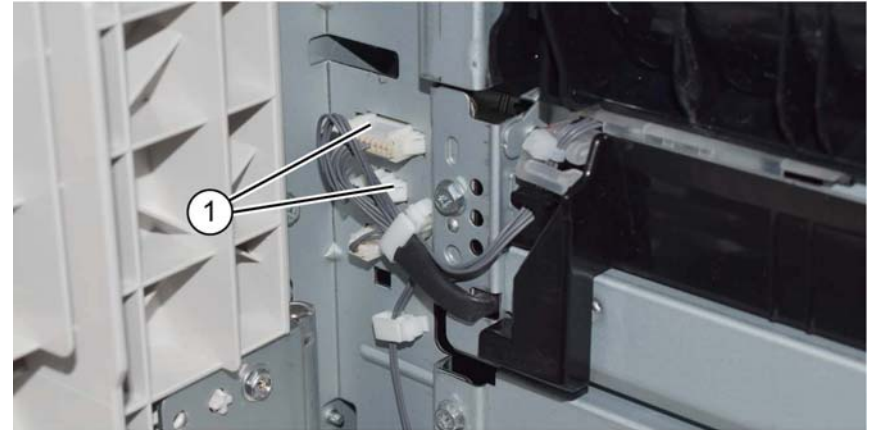
5. Disconnect 2 connectors (1), [Figure 2](#).

Figure 2 Connectors

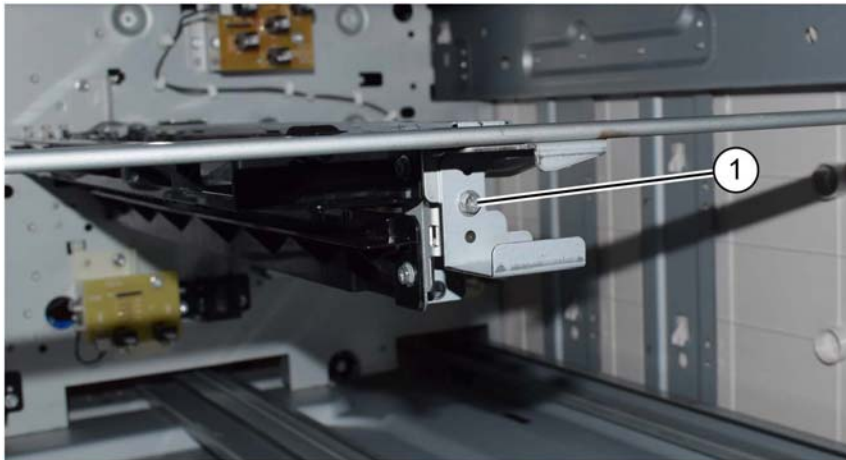
1. Pull out tray 2, 3 and 4. Remove the paper.
2. Lift out tray 3 and 4. Remove tray 2.
3. Remove the support bracket (1), [Figure 1](#).

Figure 1 Support bracket removal

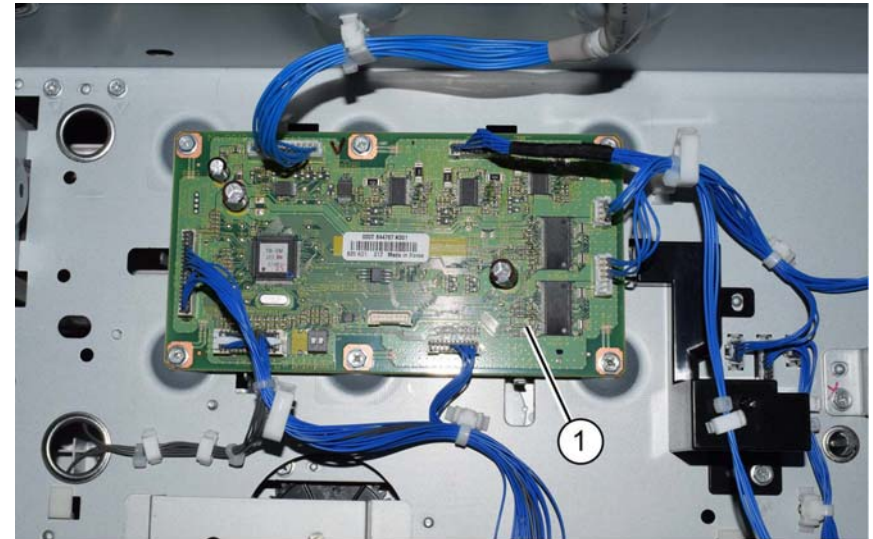
C-1-0514-A

1. Remove the TTM rear cover, [PL 70.95 Item 8](#).
2. Remove the TTM PWB, [Figure 2](#):
  - a. Disconnect seven connectors.
  - b. Remove six screws.
  - c. Remove the TTM PWB (1). [Figure 2](#).

Figure 2 TTM PWB removal

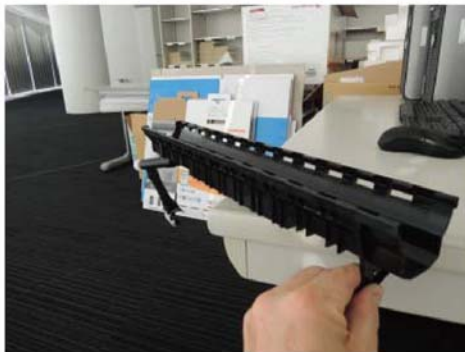
C-1-0549-A

**NOTE:** [Figure 3](#) shows the removed dispenser (K).

Figure 3 Dispenser K after removal

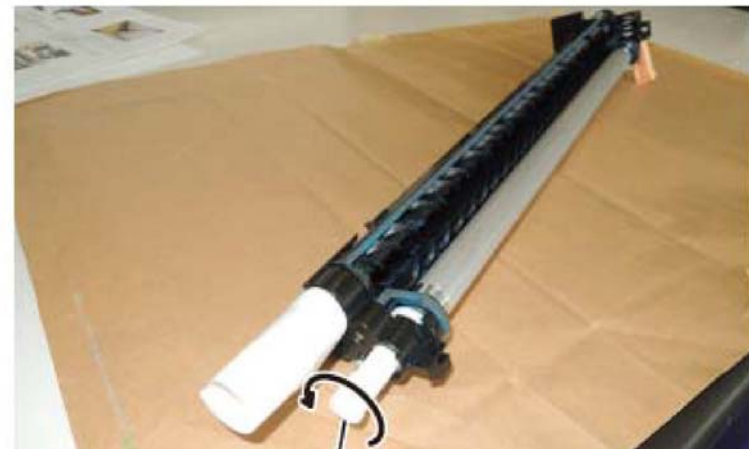
11. Uniform the developer, [Figure 7](#).
- a. Rotate the coupling in the direction of the arrow.

**Figure 7 Coupling rotation**

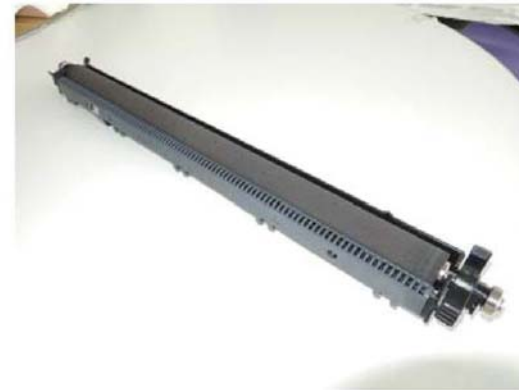
Figure 2 Removed BTR roll

Reference: [Figure 2](#) shows the removed 2nd BTR Roll.

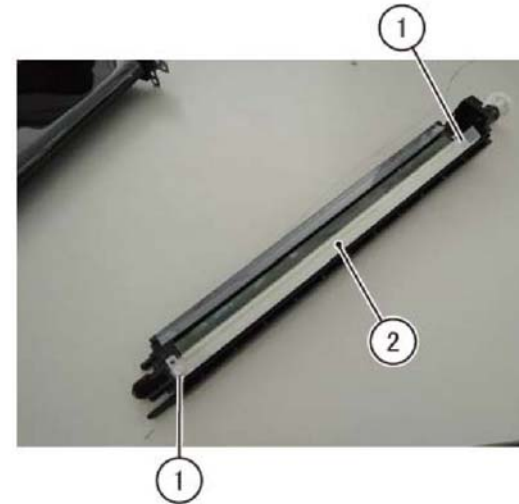
Figure 2 Blade assembly

5. Remove two screws (1) and remove the blade assembly (2), [Figure 2](#).

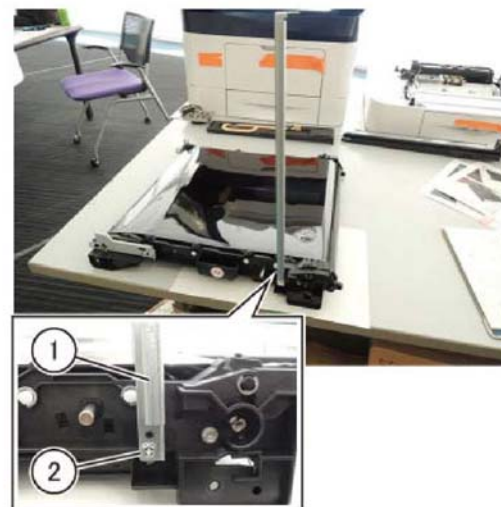
**Figure 7** IBT belt unit bottom guide install

10. Install the guide removed in step 6 on the front IBT belt unit in order to use it as a stand, [Figure 7](#).
- Install the guide.
  - Secure with tapping screw that was removed.

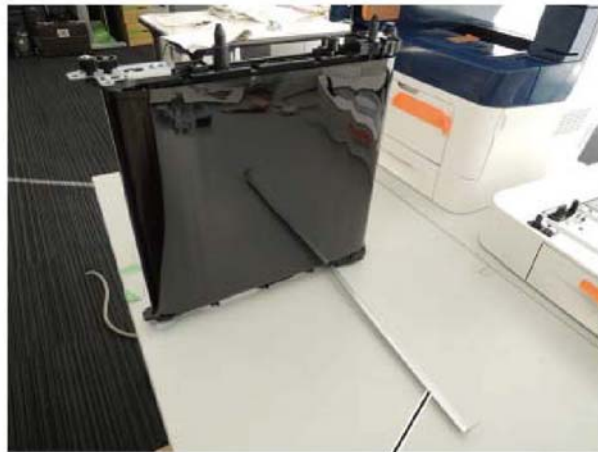
Figure 8 IBT belt unit

11. Place the rear of the IBT belt unit facing Up, [Figure 8](#).

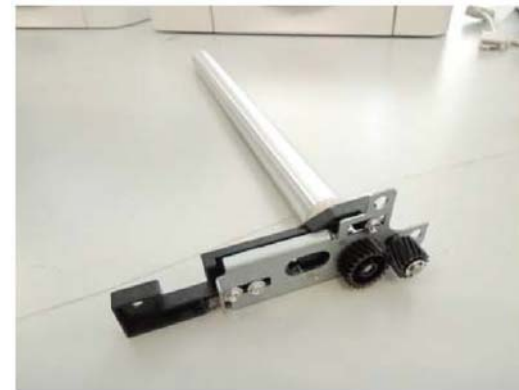
Figure 11 Rear holder and tension roll

Reference: This shows the removed rear holder and tension roll, [Figure 11](#).

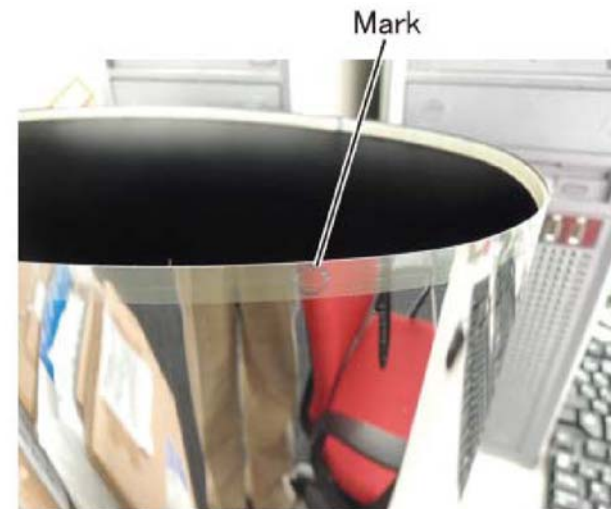
Figure 13 IBT belt mark

**NOTE:** Assemble so the mark is facing up when assembling the IBT belt.

1. The replacement is the reverse of the removal procedure.
2. Install so the IBT belt mark is on the rear side, [Figure 13](#).

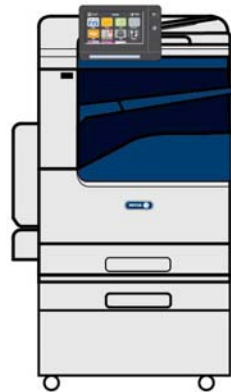
C7025 with tray 1 and 1TM

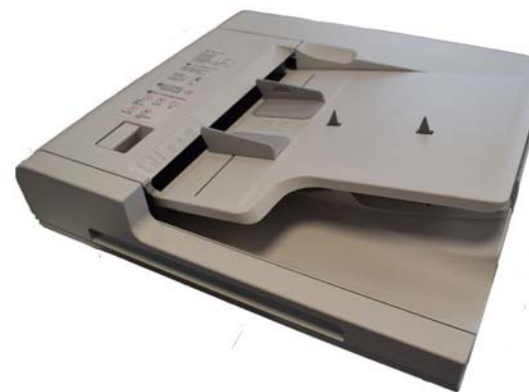
Figure 1 DADF

The DADF can invert a document to scan images on both sides, and it employs a constant velocity transport (CVT) system. With the CVT system, the lamp carriage of the IIT is fixed at a specified position (the scan position) where images are scanned as documents feed across the platen at a constant speed. Refer to Figure 1.

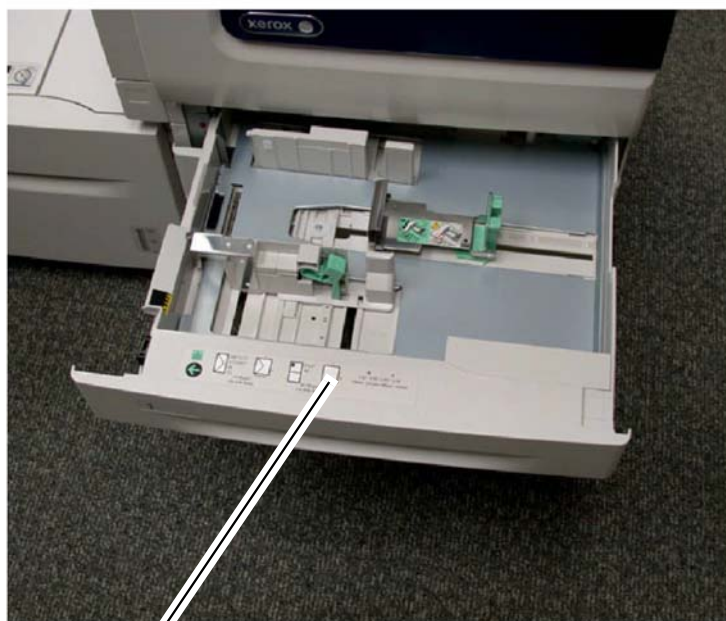
C-5-0128-A

An optional envelope tray is available, [PL 70.100 Item 1](#). The envelope tray is installed by the customer in the tray 1 position. Refer to [Figure 5](#).

Envelope tray

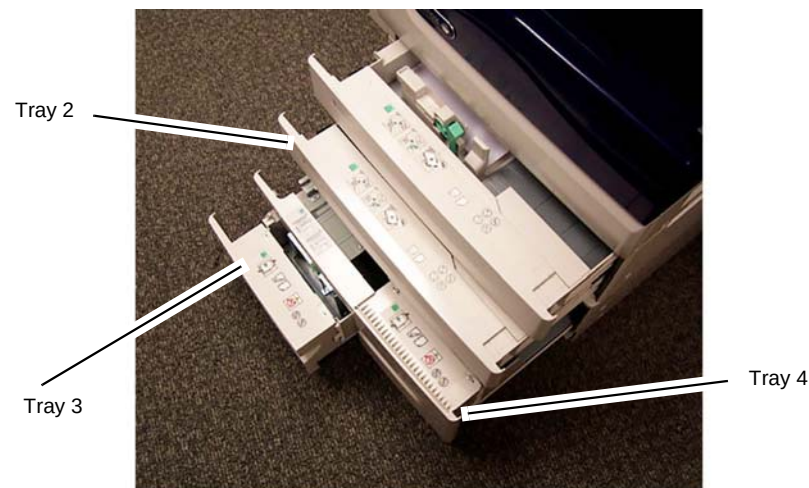
C-5-0103-A

Figure 12 TTM tray 3 and tray 4

- Tray 3: 870 sheets of A4 or 8.5 x 11 inch paper.
- Tray 4: 1130 sheets of A4 or 8.5 x 11 inch paper

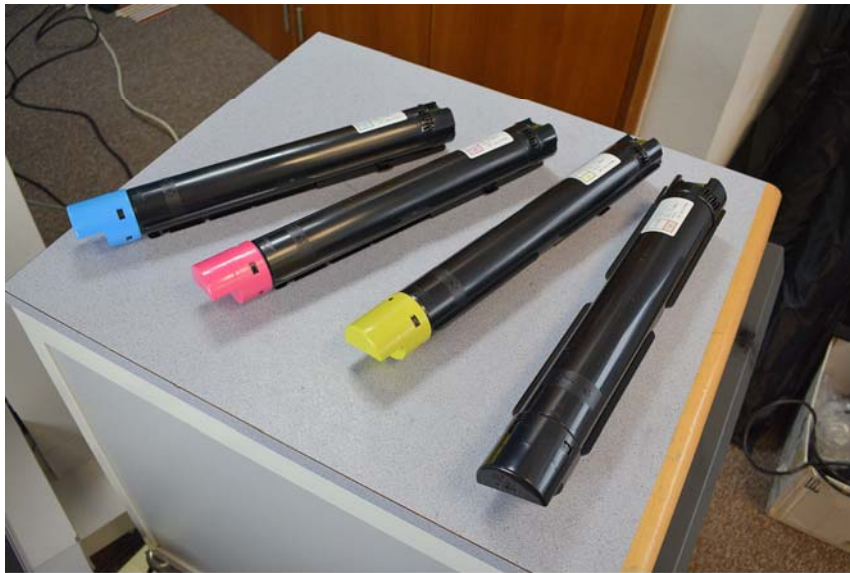
The toner cartridges, [PL 26.05](#) are customer replaceable units (CRU). The larger black toner cartridge carries a higher capacity of toner than the yellow, cyan and magenta cartridges due to the expected higher use of black toner. Refer to [Figure 2](#).

Figure 2 Toner Cartridges

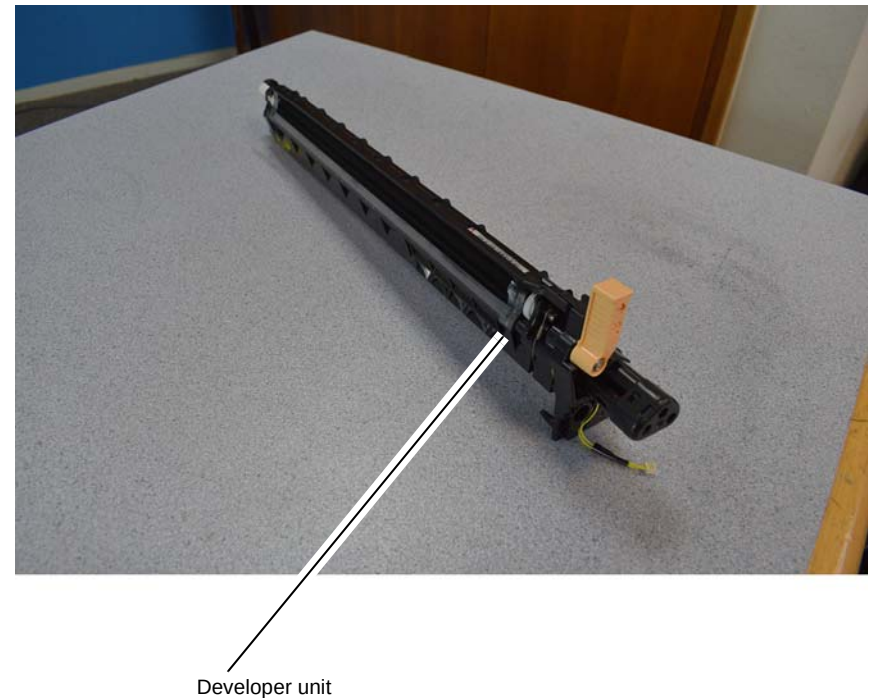
Figure 13 Developer unit

- Developer roll
- Augers (supply and toner reclamation/cleaning augers)
- Automatic toner control (ATC) sensor

Refer to [Figure 13](#).

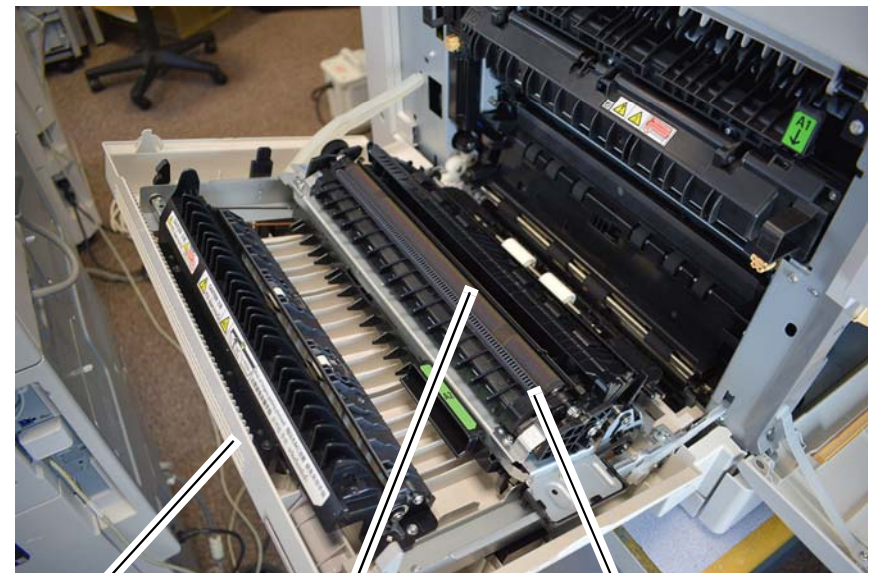
The paper is released from the transfer belt by the detack saw. A voltage is applied to the detack saw to eliminate the charge on the paper. Refer to [Figure 21](#).

**NOTE:** The detack saw is part of the 2nd roll assembly, [PL 90.40 Item 5](#).

L/H cover

2nd Bias transfer  
roll

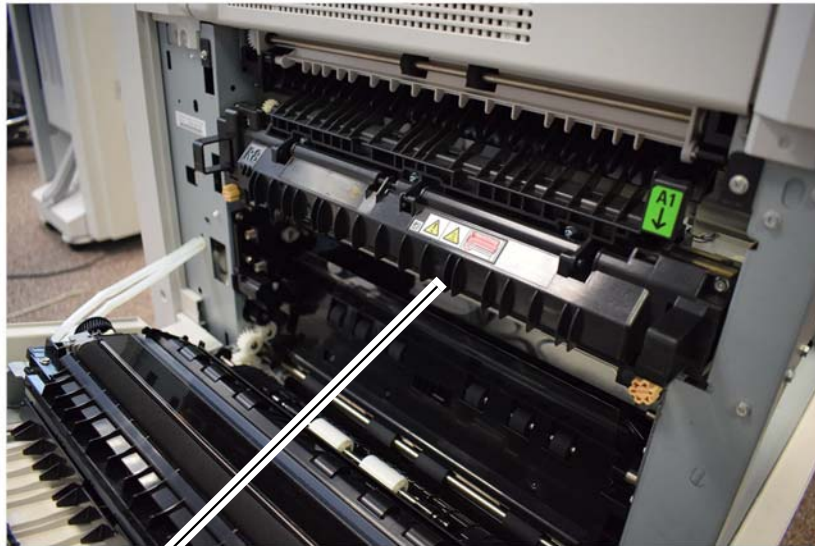
**NOTE:** There are no spare parts in the fuser assembly. The fuser is replaced as an assembly.

Fuser

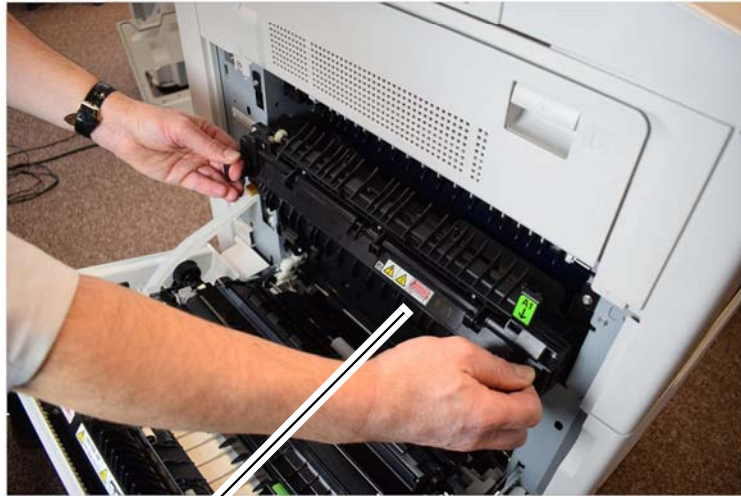
Figure 6 Fuser replacement

After installing a new fuser, the HFSI counters are reset automatically. Refer to [Figure 6](#).

Each A4 LEF fed sheet is counted as 10 HFSI counts. When the HFSI counter (chain-link 954-850) reaches a value of 1,000,000 (100,000 x 10), the CSE will be notified on the HFSI counter UI diagnostics screen that the fuser should be replaced. Note that the machine and fuser will continue to run if the fuser is not replaced at this time.

The fuser assembly will also age/degrade due to extended usage time. The ON time HFSI counter (chain-link 954-851) keeps track of machine ON time in seconds. When this HFSI reaches a count of 18,000,000 seconds (approximately 208 days), the CSE will be notified on the HFSI counter UI diagnostics screen that the fuser should be replaced. Note that the machine and fuser will continue to run if the fuser is not replaced at this time.

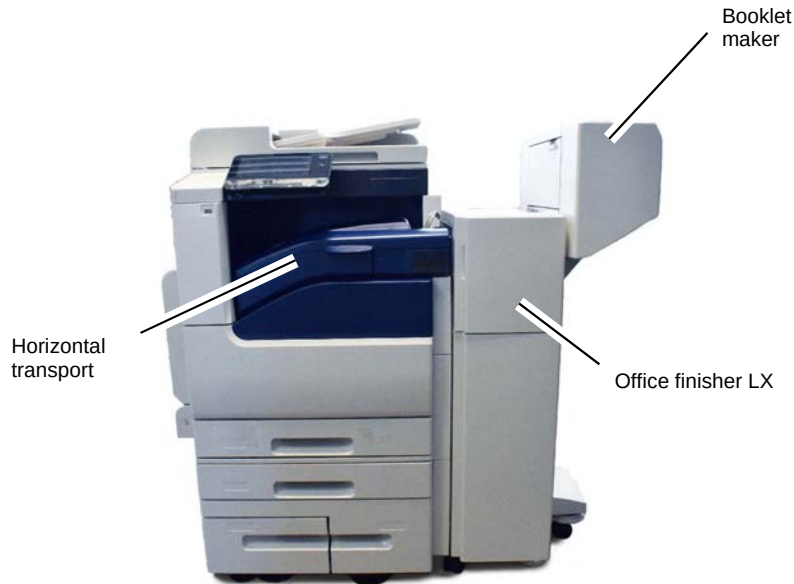
Figure 1 Overview

- [Horizontal Transport Assembly](#) - feeds the sheets exiting from the IOT to the finisher.
- **Finisher** - squares up the edges of sheets in the compiler tray to create sets and ejects/offsets the sets into the stacker tray.
- [Compiler Stapler](#) - Staples sets as specified.
- [Hole Punch Assembly](#) - Punches 2, 3 or 4 holes depending on the market. If ordered by the customer, the punch unit is in the horizontal transport.
- [Stacker Tray](#) - Collects the sets ejected from the finisher.
- [Booklet Maker](#) - (optional) saddle stitches and creases booklets

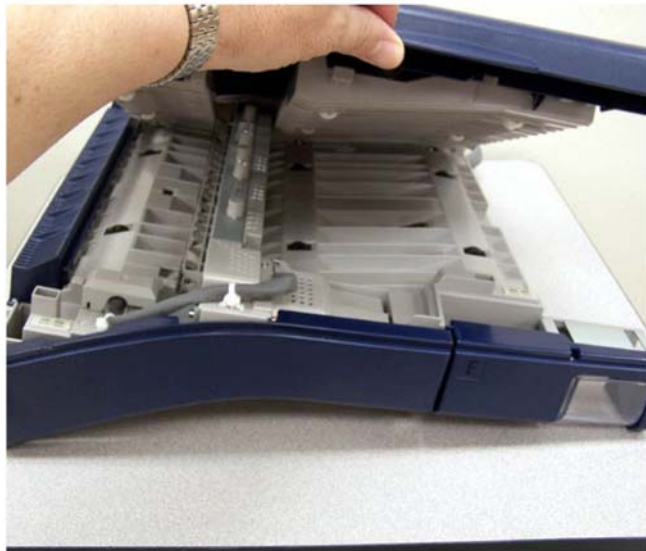
Figure 4 Horizontal transport assembly

The top cover can be opened for jam clearance. Refer to [Figure 4](#).

**NOTE:** If a booklet maker also is installed, the hole punch is installed in the horizontal transport.

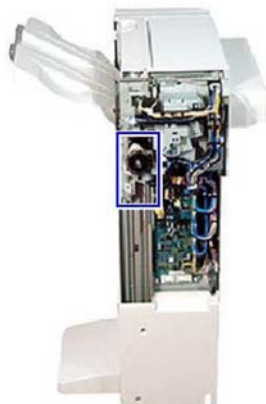
Stacker no paper sensor

The uppermost position of the stacker tray is monitored by the stacker no paper sensor. When actuated, this indicates that the stacker tray is in the uppermost feed position. Refer to [Figure 14](#).

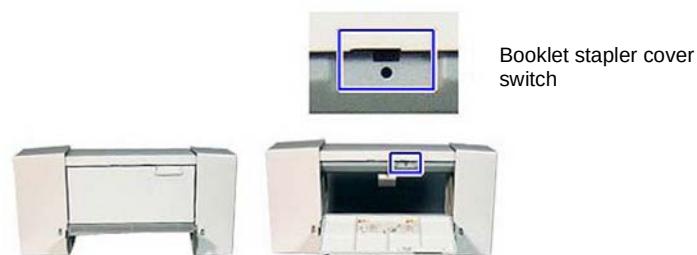
C-5-0050-A

The booklet stapler cover switch is actuated when the side cover is opened. When actuated, all + 24V supplies are removed from the booklet maker. Refer to [Figure 32](#).

Figure 32 Booklet stapler cover switch

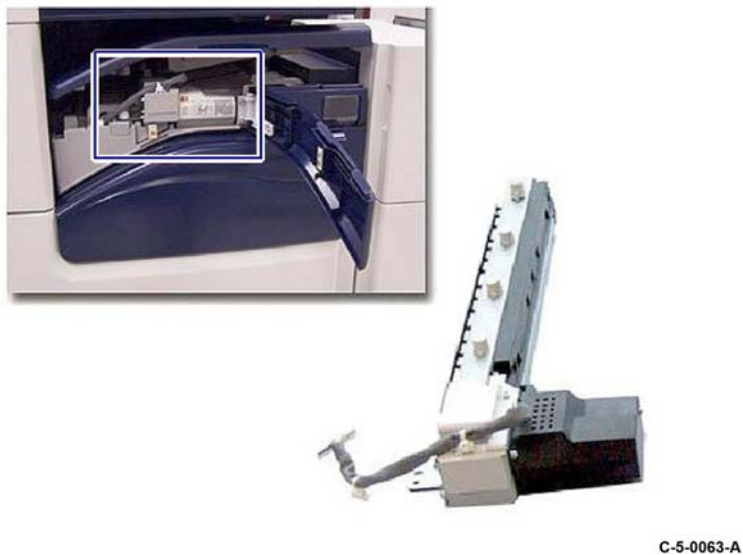
The hole punch assembly punches either 2 or 4 holes in Europe or 2 or 3 holes in North America. The hole punch assembly is installed within the horizontal transport. It is controlled by the finisher PWB. Refer to [Figure 44](#).

Figure 44 Hole punch assembly

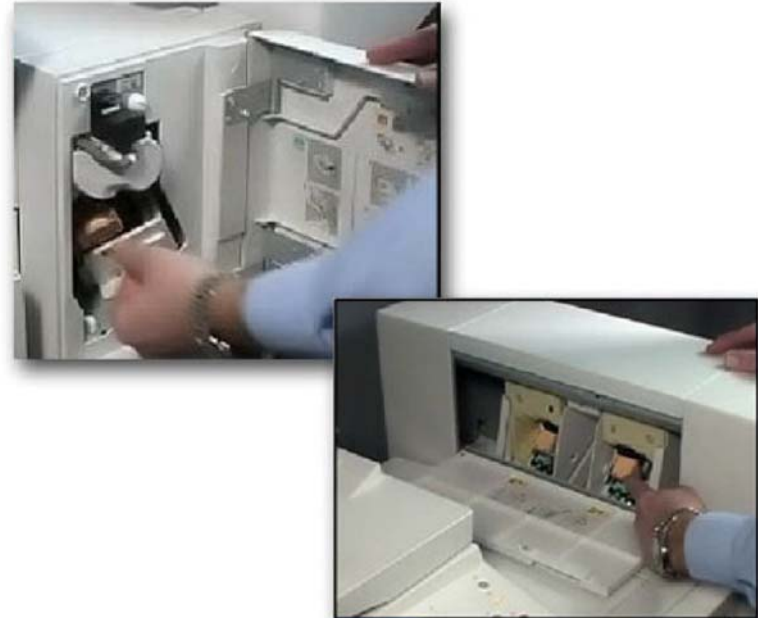
C-5-0068-A

Refer to [Figure 49](#). The only customer replaceable units (CRUs) for the LX finisher are:

- The 5,000 stitch staple cartridge and
- The two staple cassettes for the booklet maker. Each of the staple cassettes holds 2,000 staples.

Figure 49 Customer replaceable units
