# **Xerox® VersaLink® B7025/B7030/B7035**

## **Multifunction Printer**

### **Service Manual**

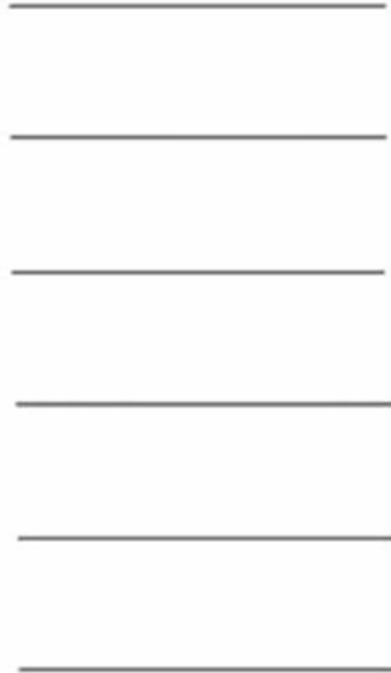
Y-1-0426-A

Regular pitch toner contamination in the process direction. Refer to [Figure 1](#).

Figure 1 Example

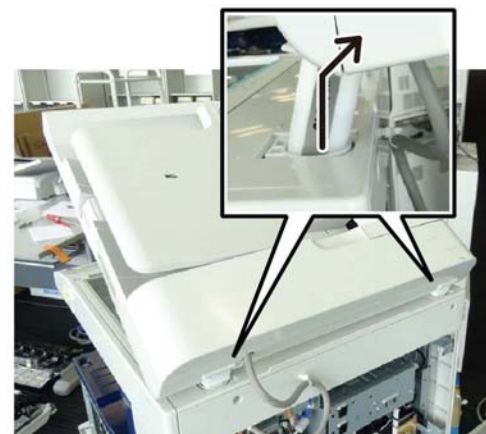
Y-1-0032-A

4. Remove the DADF, [Figure 2](#).

Figure 2 DADF removal

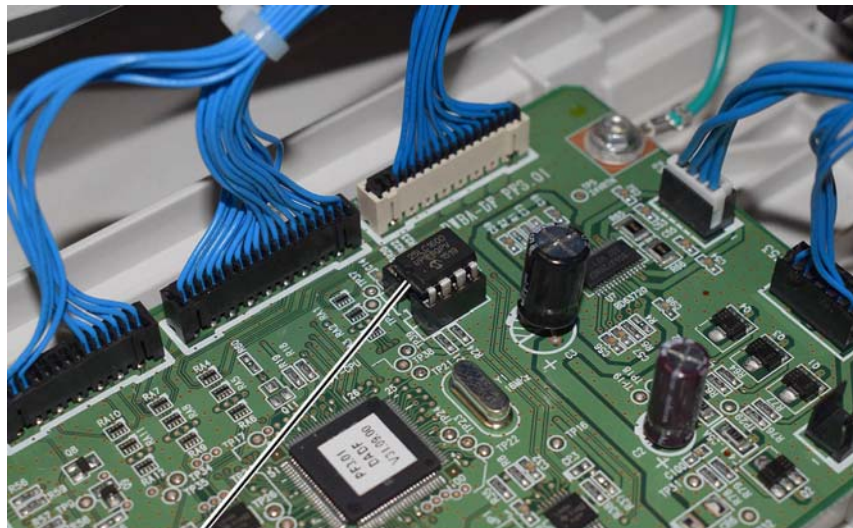
Y-1-0550-A

*Take care when removing and reinstalling the SEEPROM. The pins are easily damaged.*

- Remove the SEEPROM (1) from the old DADF PWB, then install it onto the new DADF PWB, **Figure 4**.

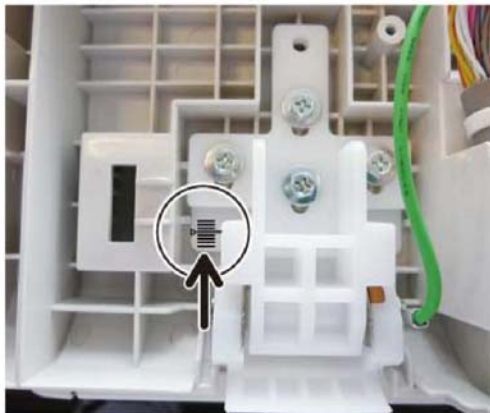
Figure 1 Position

1. Remove the DADF rear cover, [REP 5.4](#).
2. Remove the DADF, [REP 5.1](#).
3. Record the position of right counter balance, [Figure 1](#).

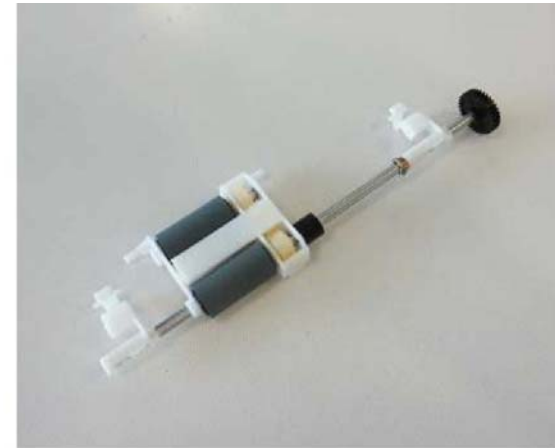
Figure 2 Removed feed/nudger roll assembly

**NOTE:** The removed feed/nudger roll assembly is shown in [Figure 2](#).

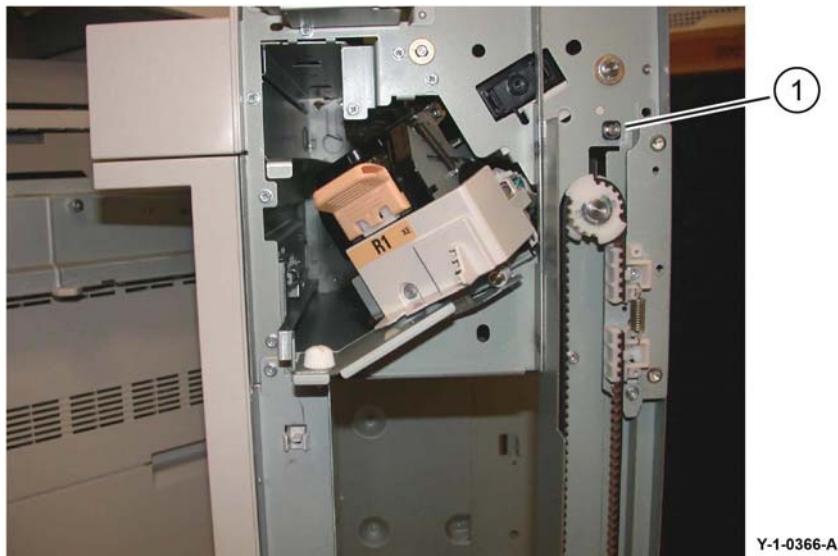
Y-1-0366-A

13. Remove the front E-ring and the bushing (1) from the set clamp shaft assembly, [Figure 5](#).

Figure 5 Front E-ring removal

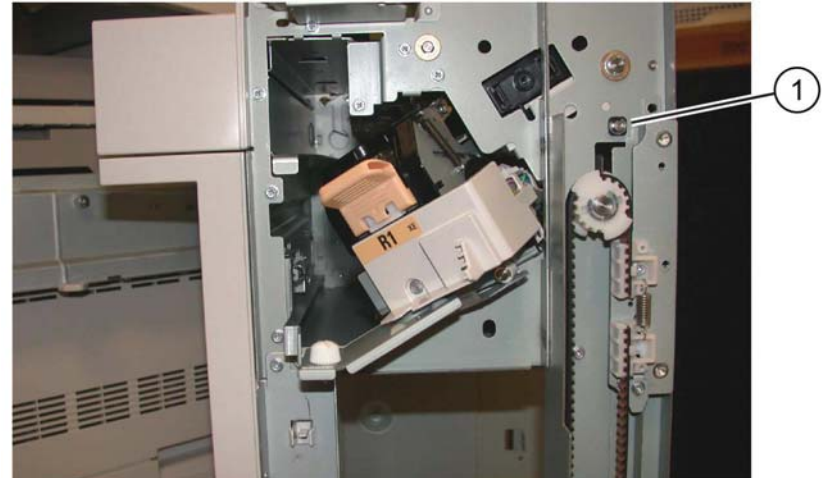
Figure 16 Bushing and E-ring

9. Install the bushing onto the front end of the set clamp shaft, then install the E-ring (1), [Figure 16](#).

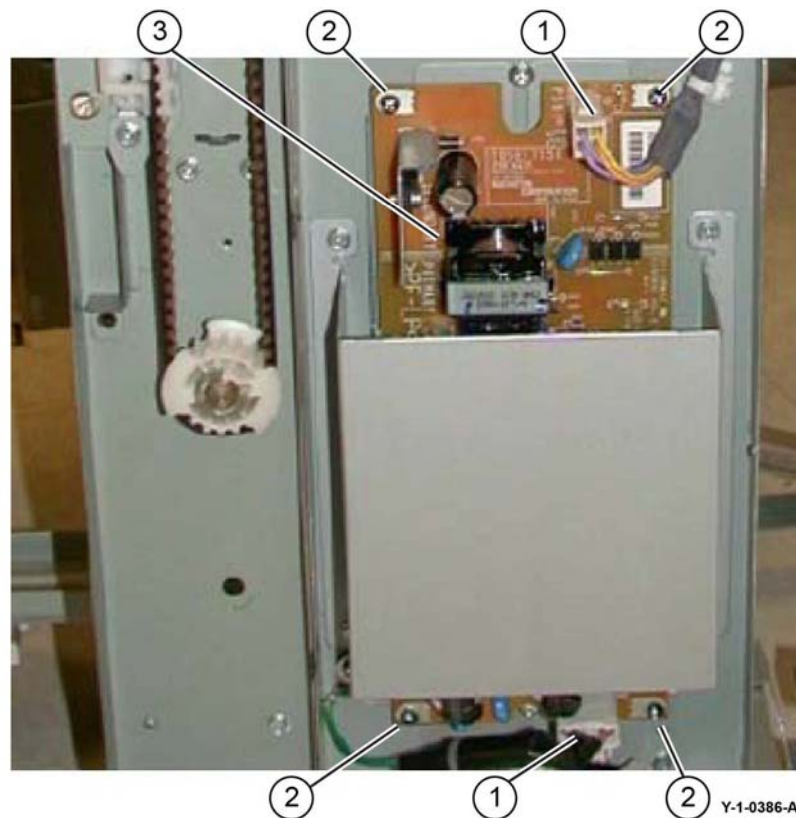
Figure 1 Finisher LVPS removal

1. Remove the rear lower cover, [REP 13.8](#).
2. Remove the finisher LVPS, [Figure 1](#):
  - a. Disconnect both Connectors (1).
  - b. Remove four screws (2).
  - c. Remove the finisher LVPS (3).

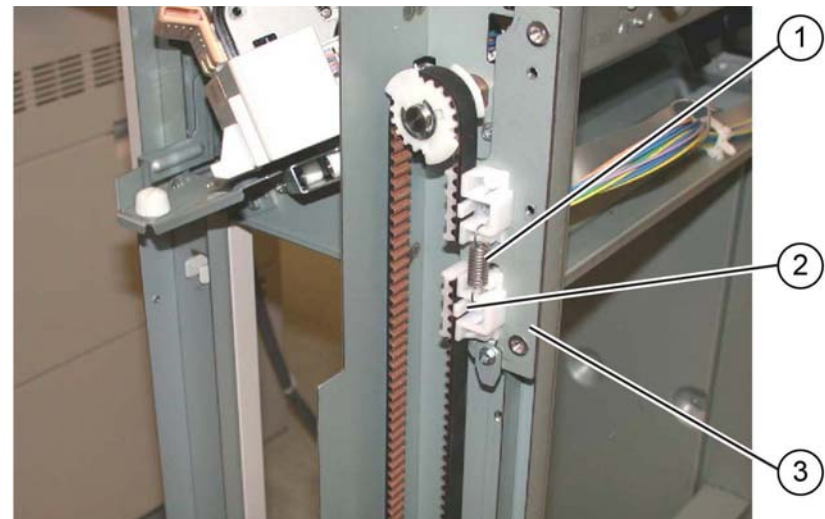
Figure 1 Carriage assembly removal

1. Enter **dc330**, code 12-060 stacker motor up, to fully raise the stacker tray.
2. Remove the finisher front cover, [REP 13.6](#).
3. Remove the rear upper cover, [REP 13.7](#).
4. Remove the rear lower cover, [REP 13.8](#).
5. Remove the stacker tray, [REP 13.20](#).
6. Removing the carriage assembly, [Figure 1](#):
  - a. Disconnect, then remove the spring (1).
  - b. Use a flat bladed screwdriver to release the belt clamp latch (2).aside and
  - c. Remove the stacker belt and carriage assembly.

**NOTE:** . The carriage bearings (2 each assembly) are not fastened to the shafts. Ensure the bearings are retained when the carriage assembly is removed.

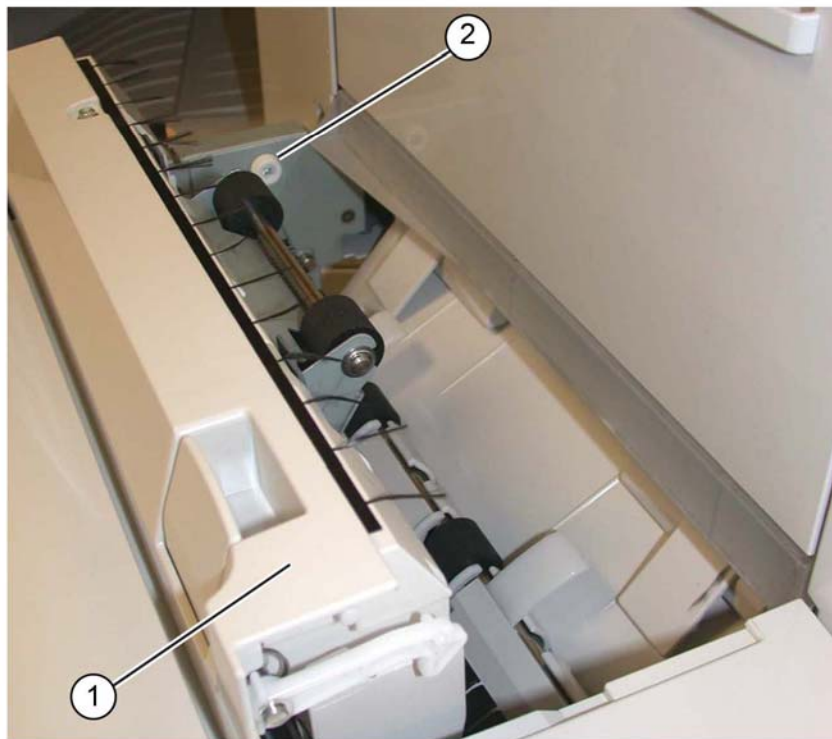
Figure 1 Preparation

1. Prepare to remove the booklet maker assembly, [Figure 1](#):
  - a. Unlatch the eject cover (1), then move it all the way to the left.
  - b. Remove the front and rear thumbscrews (2).

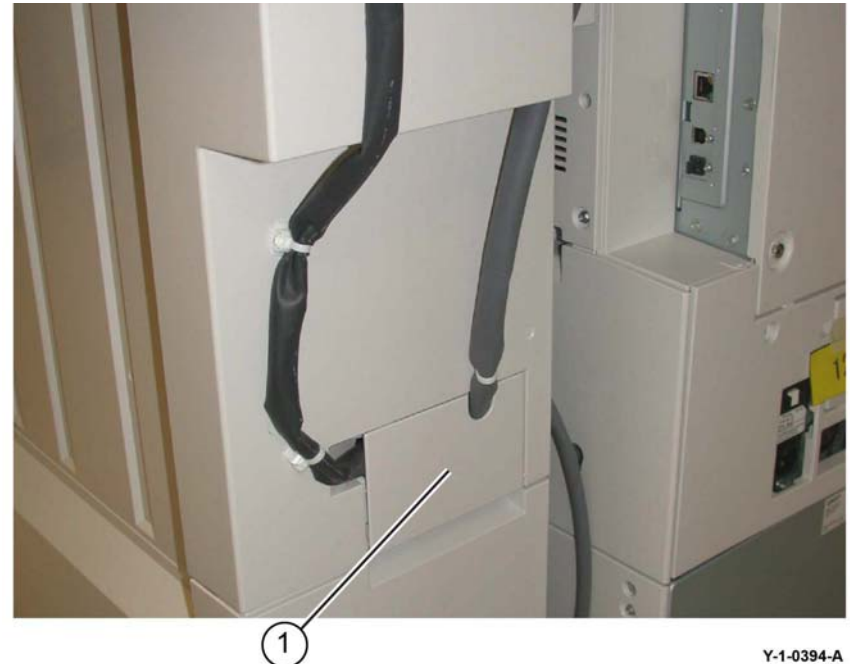
Figure 2 Connector cover

2. Remove the connector cover (1), [Figure 2](#).

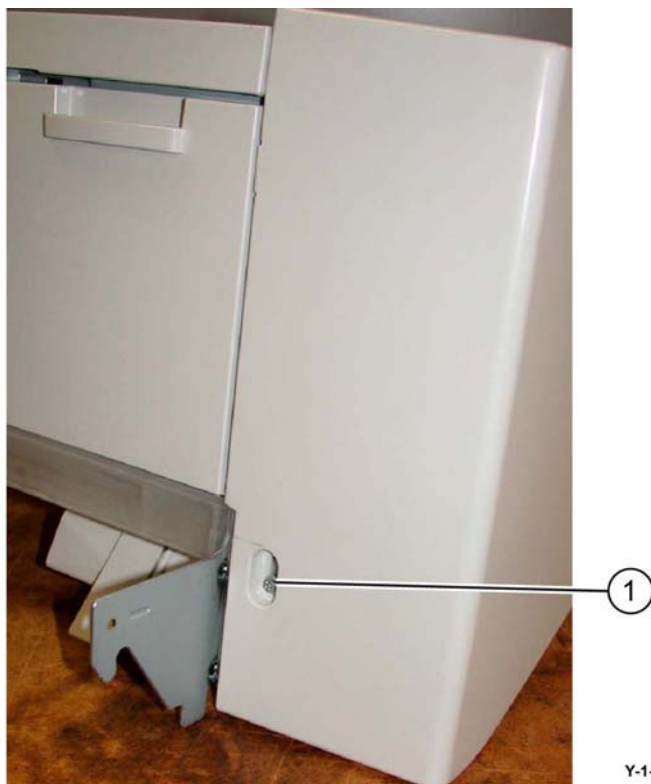
Figure 1 Screw removal

1. Remove the booklet maker assembly from the finisher, [REP 13.31](#).
2. Remove the screw (1), [Figure 1](#).

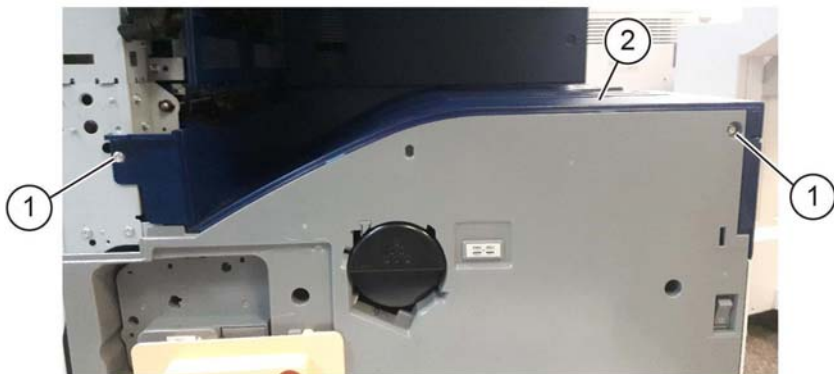
Y-1-0110-A

1. As necessary, remove the:
  - Integrated finisher, [REP 12.1](#).
  - Office finisher LX, [REP 13.5](#).
  - Horizontal transport, [REP 13.1](#).
2. Open the front cover.
3. Remove the pillar left cover, [PL 28.05 Item 13](#).
4. Remove the exit front cover, [PL 28.05 Item 10](#).
5. If an office finisher LX was installed, remove the components that follow:
  - a. Upper adjust cover, [PL 13.10 Item 18](#) and lower adjust cover, [PL 13.10 Item 19](#).
  - b. Docking plate, [PL 13.05 Item 3](#).
  - c. Docking bracket, [PL 13.05 Item 7](#).
6. Remove the top cover, [Figure 1](#):
  - a. Remove two screws (1).
  - b. Remove the top cover (2).

Figure 1 Top cover removal

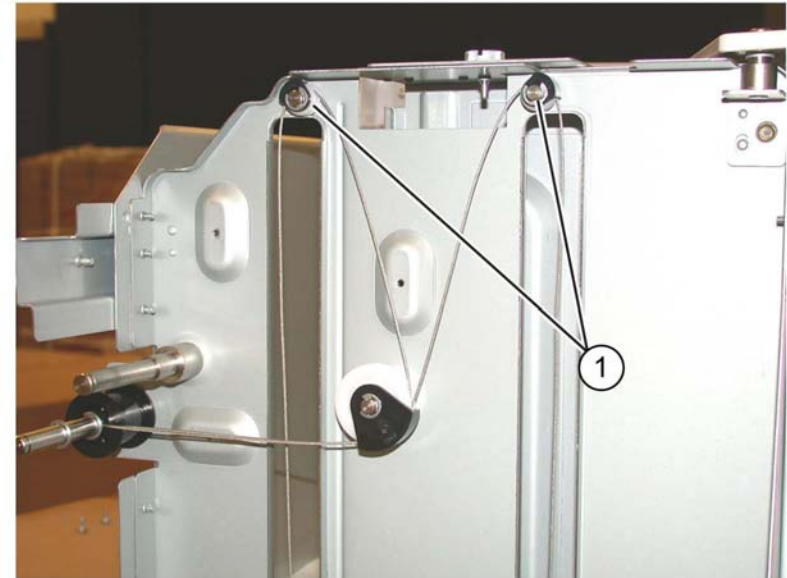
Y-1-0461-A

4. Prepare to remove the tray rear cables. Remove two E-rings, wire guides and pulleys (1), [Figure 3](#).

Figure 3 Preparation

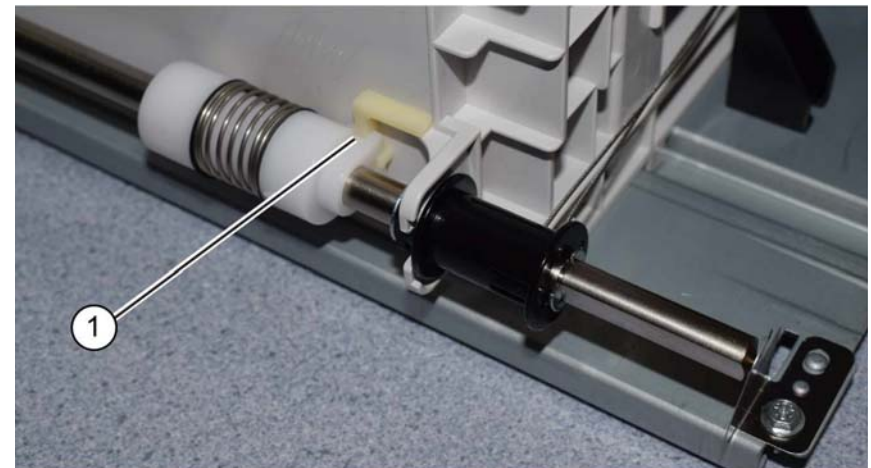
Y-1-0484-A

3. Ensure the brake (1) is correctly positioned against the tray frame, Figure 6.

Figure 6 Brake

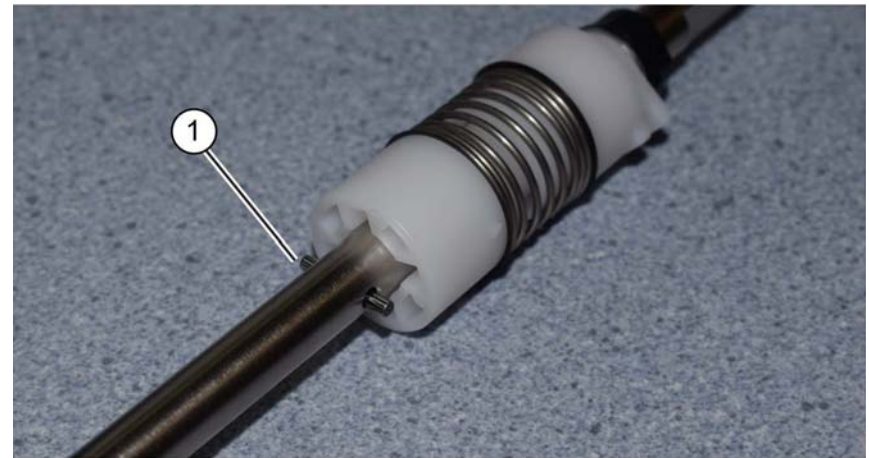
Figure 5 Pin

2. Ensure the brake securing pin (1) is installed correctly, Figure 5.

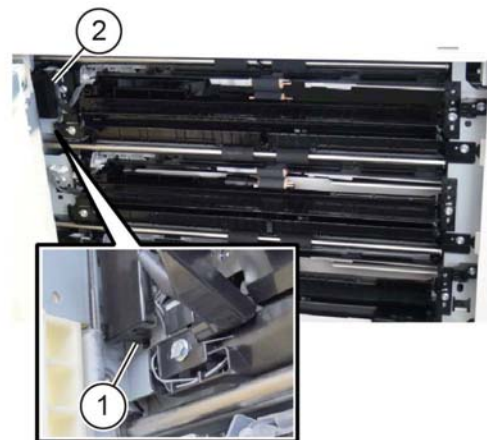
Figure 1 ESD cover removal

1. Pull out tray 2. Remove the paper.
2. Remove tray 2.
3. Open the left cover assembly, [PL 70.20 Item 11](#).
4. Remove the ESD cover, [Figure 1](#):
  - a. Disengage the hook (1).
  - b. Remove the ESD cover (2).

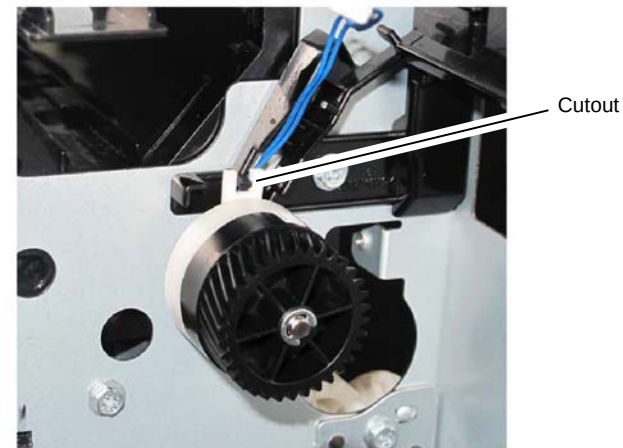
Y-1-0232-A

1. The replacement is the reverse of the removal procedure.
2. When installing the registration clutch assembly, align the cutout with the harness guide tab, **Figure 5**.

**Figure 5 Alignment**

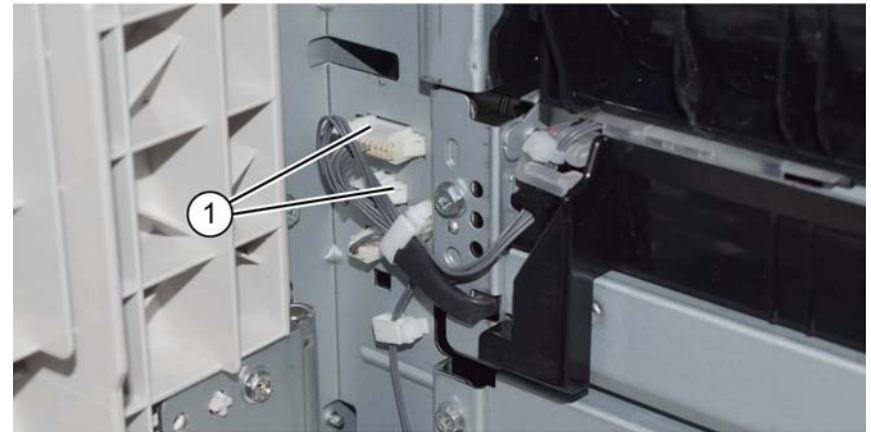
5. Disconnect 2 connectors (1), [Figure 2](#).

Figure 2 Connectors

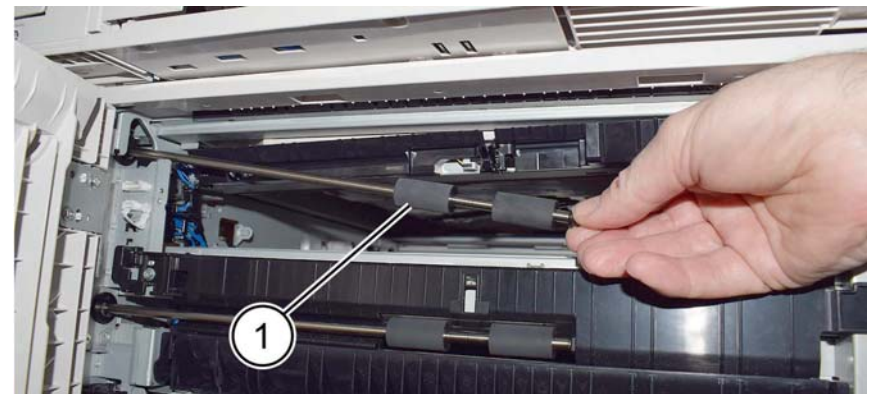
9. Remove the takeaway roll (1), [Figure 4](#).

Figure 4 Takeaway roll removal

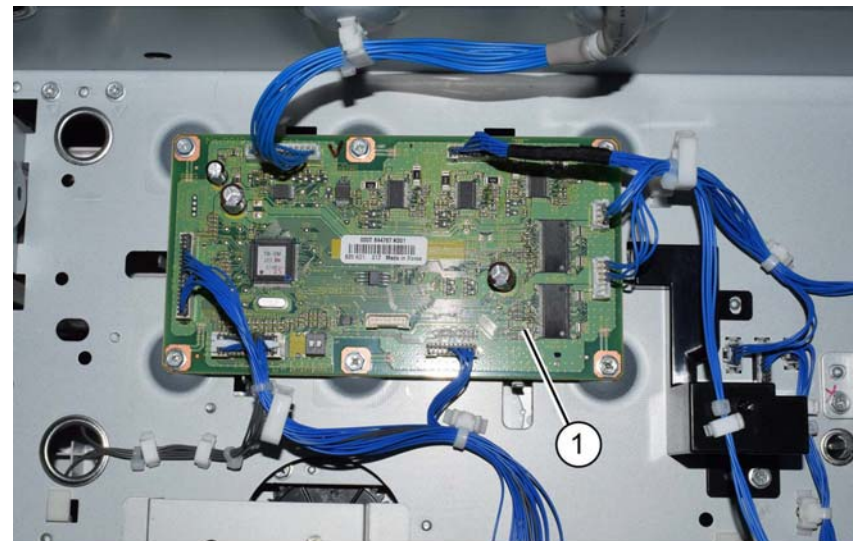
1. Remove the TTM rear cover, [PL 70.95 Item 8](#).
2. Remove the TTM PWB, [Figure 2](#):
  - a. Disconnect seven connectors.
  - b. Remove six screws.
  - c. Remove the TTM PWB (1).

Figure 2 TTM PWB removal

1. The replacement is the reverse of the removal procedure.
2. If a new TTM PWB is installed, change the value of NVM ID 742-205 to 2.

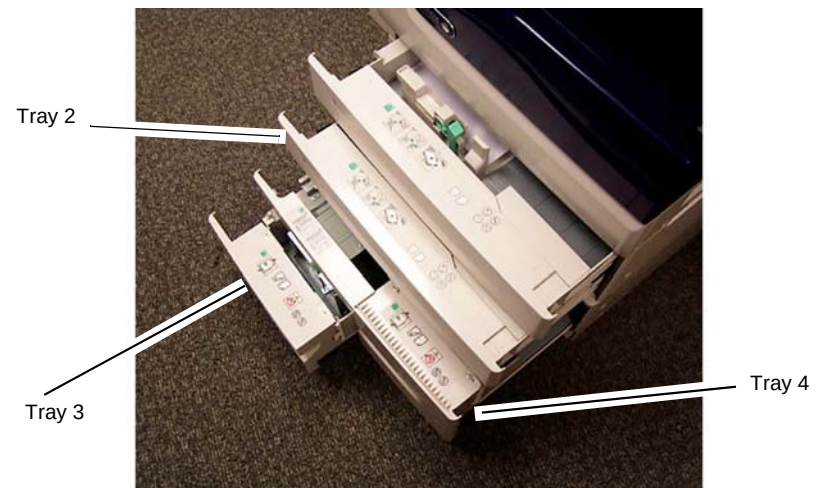
Y-5-0103-A

- Tray 3: 870 sheets of A4 or 8.5 x 11 inch paper.
- Tray 4: 1130 sheets of A4 or 8.5 x 11 inch paper

**Figure 12 TTM tray 3 and tray 4**

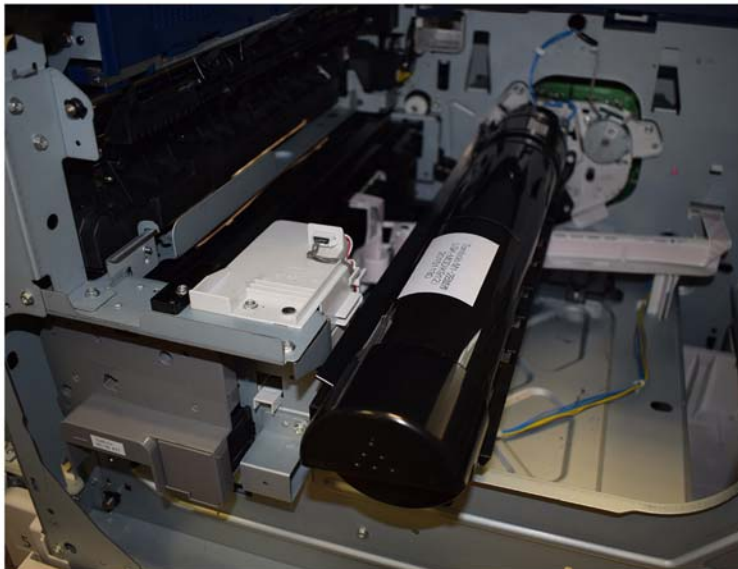
Figure 1 Main xerographic components

The print engine uses the following components in the xerographic process, refer to Figure 1.

- Toner cartridge (customer replaceable unit).
- Toner dispenser assembly.
- Drum cartridge (customer replaceable unit).
- Laser Print Head (LPH).
- Bias Transfer Roller (BTR) (customer replaceable unit).
- HVPS.

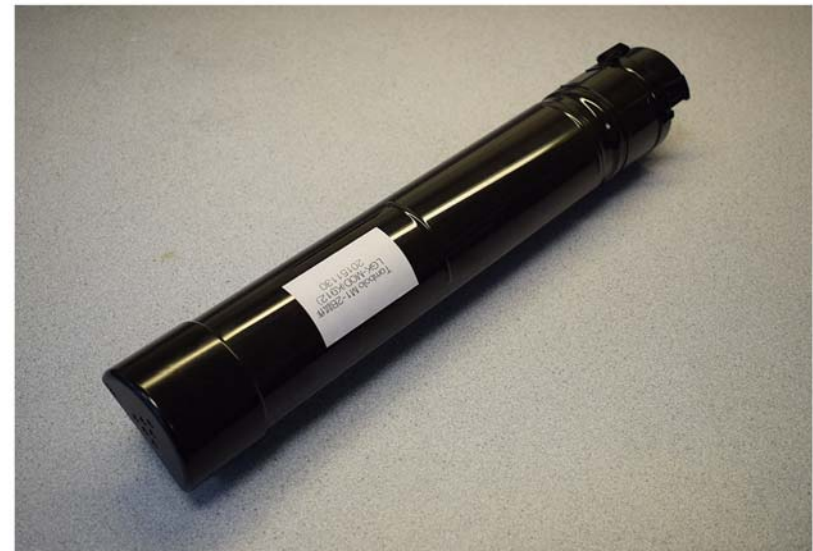
Figure 2 Toner Cartridge

The toner cartridge is a customer replaceable unit (CRU) with sufficient toner capacity for up to 30 000 feeds. Refer to Figure 2.

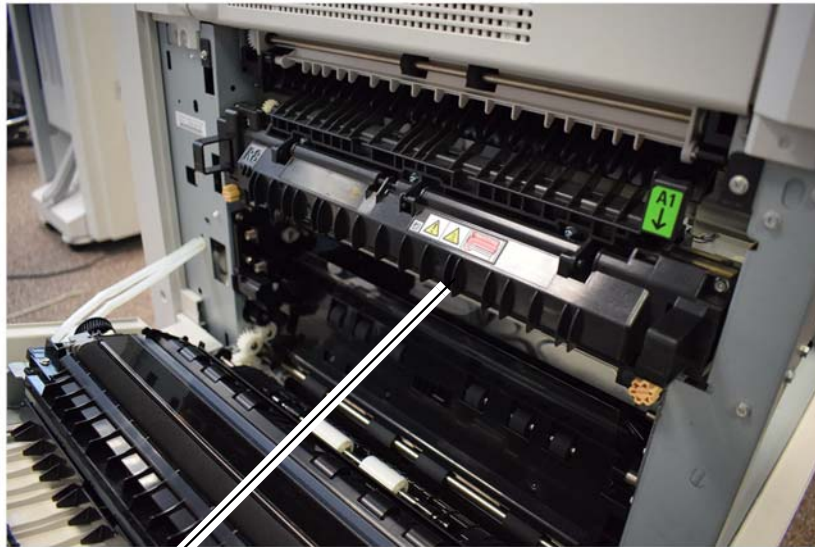
Fuser

**NOTE:** There are no spare parts in the fuser assembly. The fuser is replaced as an assembly.

Refer to [Figure 1](#).

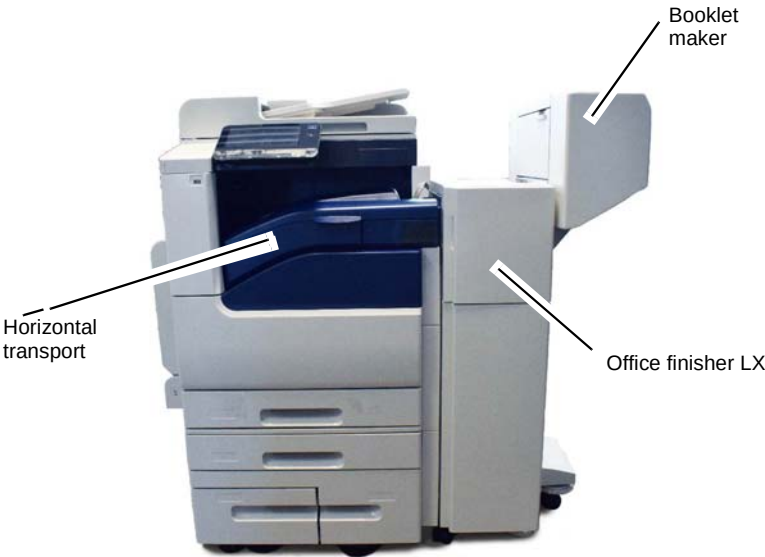
Figure 1 Overview

The finisher LX can collate, stack, staple, and hole punch up to 2000 sheets or 200 sets of 90gsm or 20lb paper. For paper sizes greater than A4 SEF, the maximum number of sets is limited to 100. Refer to Figure 1.

NOTE: The finisher cannot handle transparencies or envelopes.

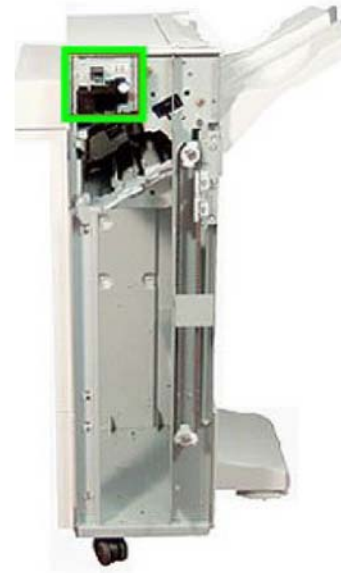
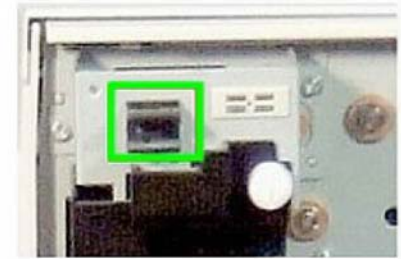
Y-5-0029-A

- **Eject Cover Switch** - triggered when the eject cover is raised. Refer to [Figure 10](#).
- **Front Door Interlock** - triggered when the front cover is opened. Refer to [Figure 11](#).

Figure 11 Front door interlock

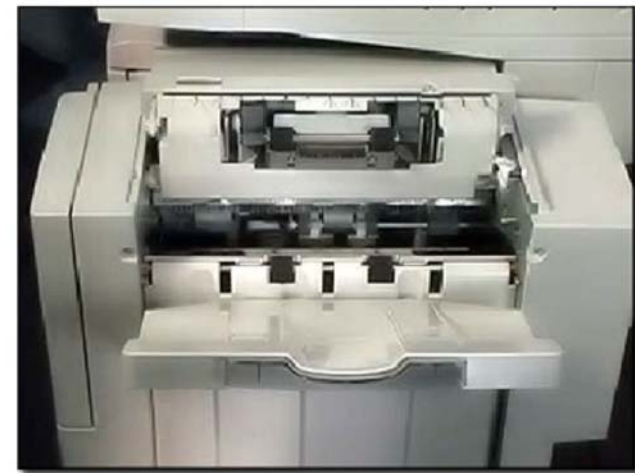
Y-5-0038-A

The sub paddles rotate constantly and only come into contact with the paper when the solenoid is actuated. Refer to [Figure 19](#), [Figure 20](#) and [Figure 21](#).

**Figure 20 Sub paddle assembly**

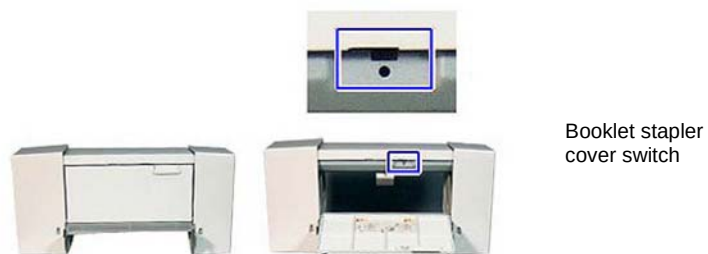
Y-5-0050-A

The booklet stapler cover switch is actuated when the side cover is opened. When actuated, all + 24V supplies are removed from the booklet maker. Refer to [Figure 32](#).

Figure 32 Booklet stapler cover switch

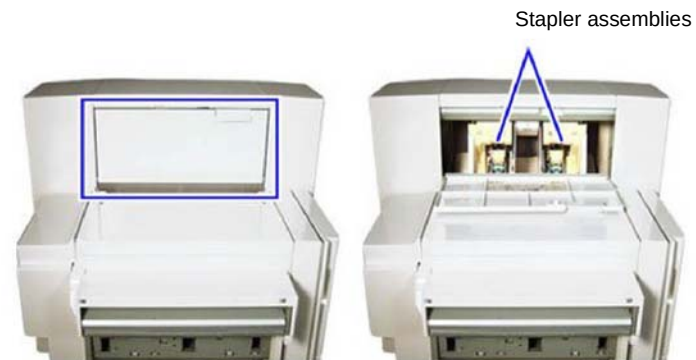
Y-5-0053-A

The booklet maker contains two staple assemblies which support and staple compiled booklets prior to ejecting into the stacker tray.

Each staple assembly contains a staple module and an exit sub chute. The staple units are mounted on a carriage rail. Refer to [Figure 35](#).

**Figure 35 Stapler assemblies**

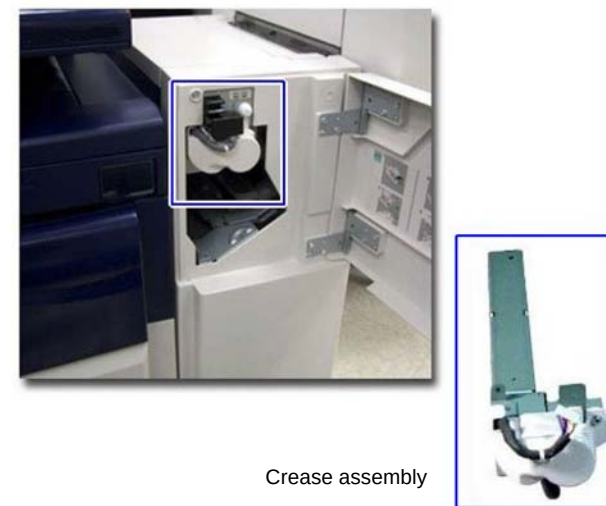
Y-5-0055-A

Figure 38 Crease assembly

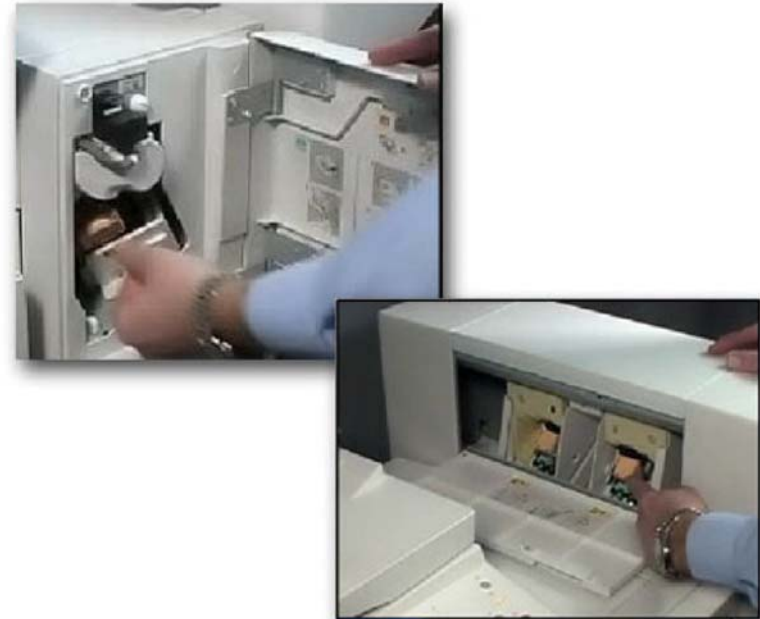
Figure 49 Customer replaceable units

Refer to [Figure 49](#). The only customer replaceable units (CRUs) for the LX finisher are:

- The 5,000 stitch staple cartridge and
- The two staple cassettes for the booklet maker. Each of the staple cassettes holds 2,000 staples.
